Impulse Mags and the Continental A65- 8 Engine

Author: John Propst Technical Advisor: Bill Pancake

Abstract – Installation of an impulse magneto on the right side of a Continental A65-8 engine may result in an interference fit between the end of the magneto and the back of the engine crankcase.

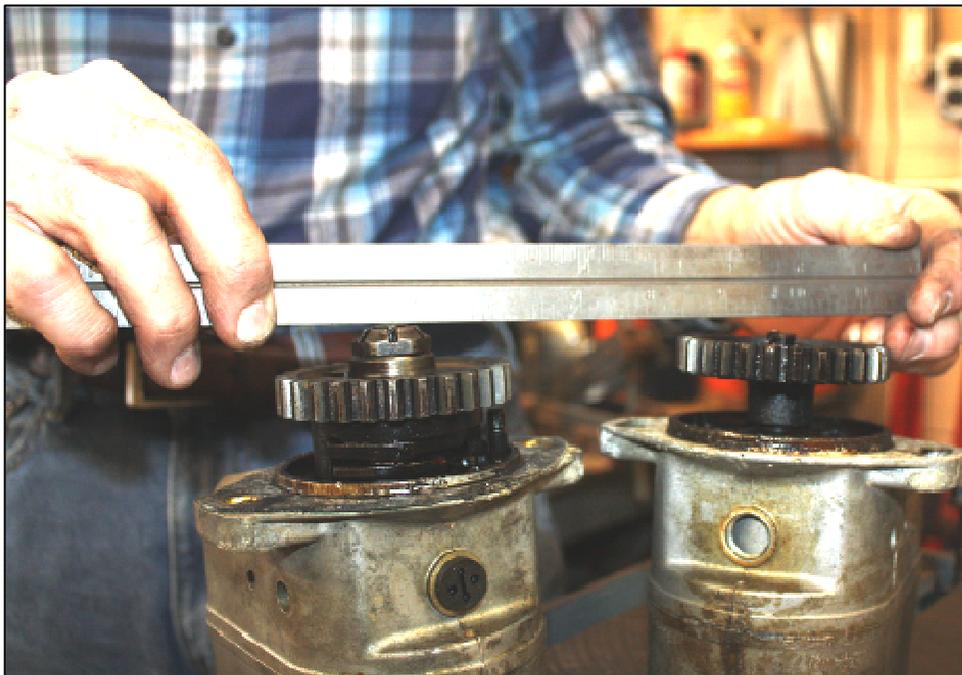
The following photo is a side by side comparison of two Bendix magnetos. The one on the left has an impulse coupling between the magneto and the drive gear while the one on the right has the drive gear attached directly to the magneto shaft.

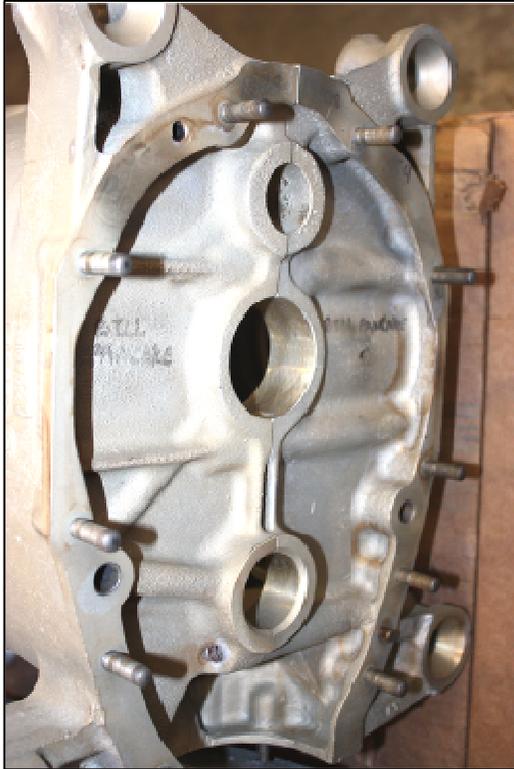
The photo on the left shows the back of a A-65 crankcase. The large bored hole near the center of the crankcase is for the engine crankshaft and the bottom bored hole is for the engine camshaft. If you look closely at the engine casting you will notice that the area to the left of the crankshaft hole is flat while the area to the right of the crankshaft hole is humped up. When the accessory case is mounted to the back of the engine, the drive gear end of the left magneto will be sticking toward the flat area immediately to the left of the crankshaft and the right magneto will be sticking toward the humped area of the crankcase immediately to the right of the crankshaft. On most A-65 engines the hole above the crankshaft hole is not machined. However, on an A-65-9 engine the hole was machined for the installation of either a Hummer or Eclipse starter mechanism. The A-65-9 engine was not

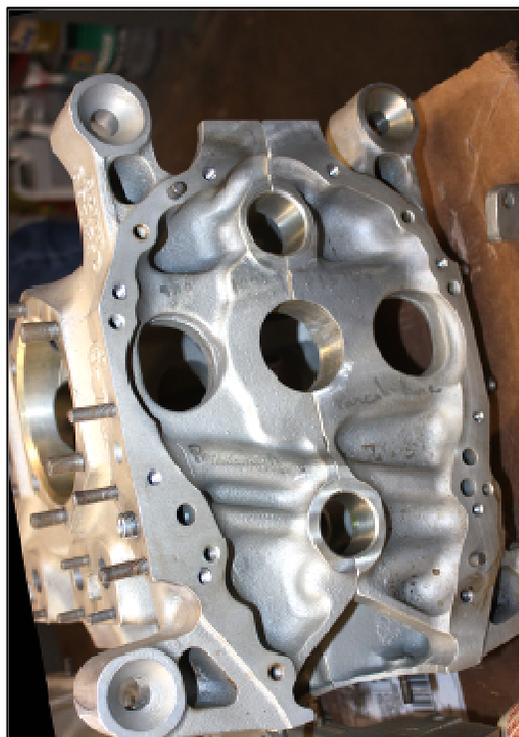
The photo on the left is a C-85-12. Note the difference between the back end of the A65-8 engine and the C85-12 engine. On the C85-12 engine the area immediately to both the left and the right of the center crankshaft hole is an open hole in the crankcase casting. When the engine accessory case is installed on the back of a C85-12 engine, the magneto shafts will face forward in these open areas of the crankcase. The crankcase castings for all of the C85, 90, and O-200 engines have the cast holes in the back of the crankcase.

As a side note to this photo, this engine is being converted (by Don Sword's STC SE0192AT) from a C85-12 engine to a C85-8 engine. This conversion requires removing two crankcase ears on the top of the crankcase and drilling and tapping

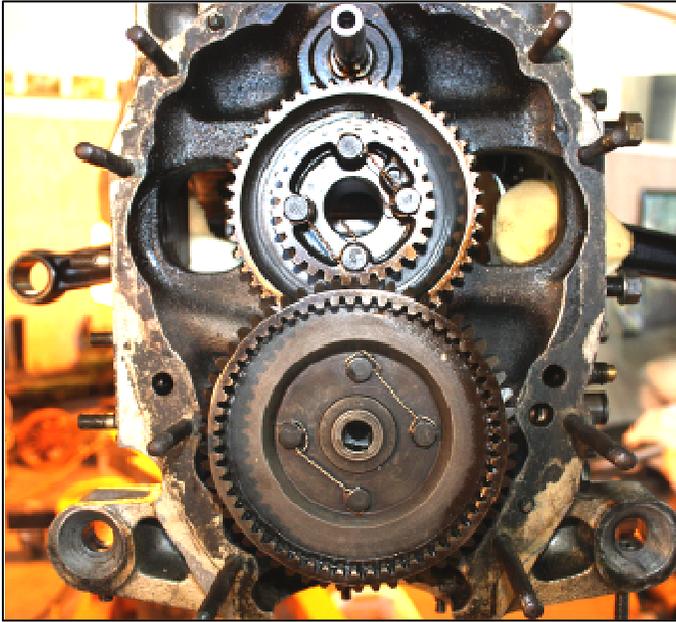
This photo shows the back end of a C-85-12 engine that is being disassembled for overhaul. In this photo you can see the pinion shaft at the top for the engine starter gear. Below that is a small gear nested within a larger gear. The larger gear is engaged by the starter. The smaller gear on the crankshaft drives the large lower gear on the camshaft. The large lower gear on the camshaft also drives the two magnetos. The inner teeth on the lower gear drive the generator. On the A-65 engine the magnetos are driven

directly from a gear on the crankshaft. That is why the A-65 magnetos run in the opposite direction from the C-85 magnetos.

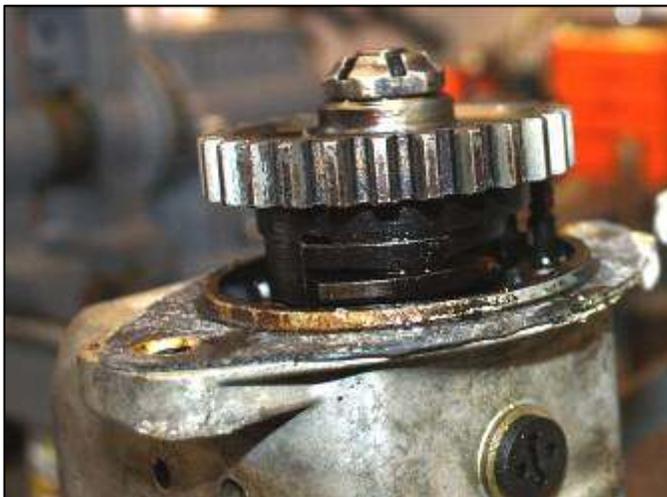
The concern is when an impulse magneto is mounted on the right side of a Continental A65-8 engine. There is the possibility that the nut and shaft on the

end of the magneto may come in contact with the hump in the back of the crankcase casting. This is especially likely if one is trying to install an older Eisemann, Bendix, or Slick impulse magneto on the right side.

is to do nothing. Mount the magneto on the engine. When the engine is put back into service the magneto shaft and nut will most likely grind a divot into the back of the crankcase. This will most likely result in damage to the magneto, possible damage to the gears and crankcase, and an accumulation of aluminum chips in the oil screen and other undesirable areas of the engine lubrication system. Obviously this method is strongly discouraged.

Another method sometimes tried is to place multiple gaskets between the magneto mounting flange and the accessory case. Note on the photo that there is a small rabbit fit shoulder on the end of the magneto case to position the magneto on the accessory case. If the use of multiple gaskets still allows the magneto to be properly positioned on the accessory case then multiple gaskets may be a solution. Be aware that over time the gaskets will shrink and that may result in the magneto contacting the crankcase.

Another method is to grind sufficient material from the crankcase to prevent the interference fit. This is not recommended. The humped area of the A-65 crankcase is already a weak area of the crankcase and any grinding in this area may result in a crankcase crack or failure.

Some of the newer Slick impulse mags for the A-65-8 engine have been redesigned and provide adequate clearance. It is up to the individual installing an impulse mag on the right side of an A-65 engine to assure that there is adequate clearance.

At one time Slick had a spacer that permitted installing an older style Slick A-65 impulse mag along with the drive gear from a C-85 Slick mag on an A-65 engine. If you are considering installing an impulse mag on a C-65-8 engine and you find there is an interference fit, the best and recommended solution is to install a non-impulse mag in its place.
