Installation of BPE-14 Wind Powered Alternator on Aeronca Champ

By John Propst with Technical Review by Bill Pancake

Abstract: this article covers the installation of a BPE-14 Wind Powered Alternator on a 1946 Aeronca Champ.

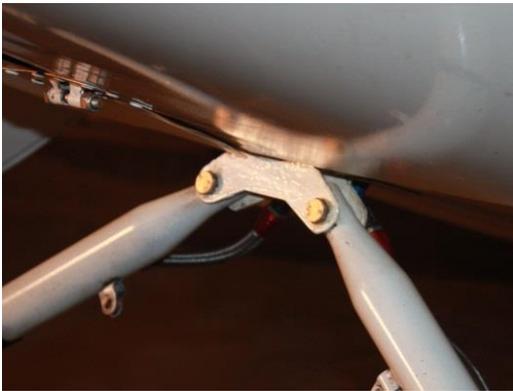
To mount the unit, the weight of the aircraft must be removed from the front landing gear so that the upper axle pivot bolts can be removed and replaced with longer bolts. As shown in the photo on the right, I fabricated a wooden spreader bar and used an engine hoist and fiber straps to lift the aircraft by

the engine mounting frame. The aircraft was raised until both wheels were slightly off the floor.

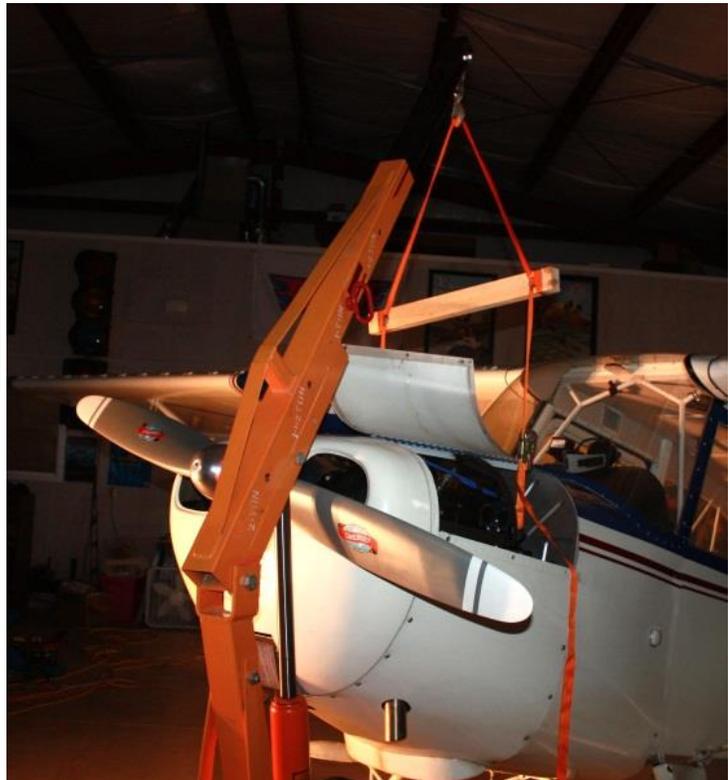
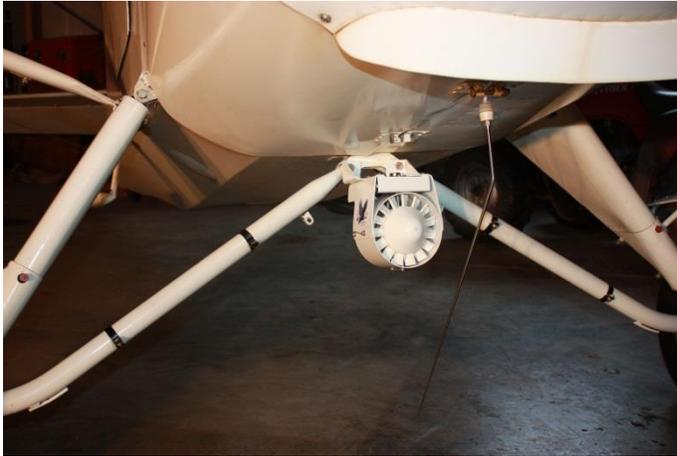
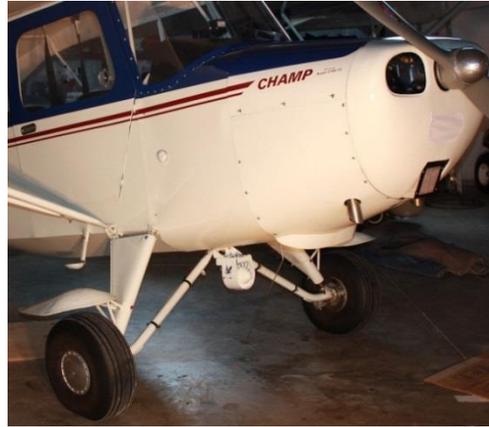
The two upper axle bolts shown on the photo above were removed. Undersized punches were inserted in the holes to temporarily position the axles in the bracket. After removing the existing bolts, new bolts approximately 1/8" longer than the existing bolts were used to mount the new alternator on the axle attachment bracket as shown in the photos on the next page.

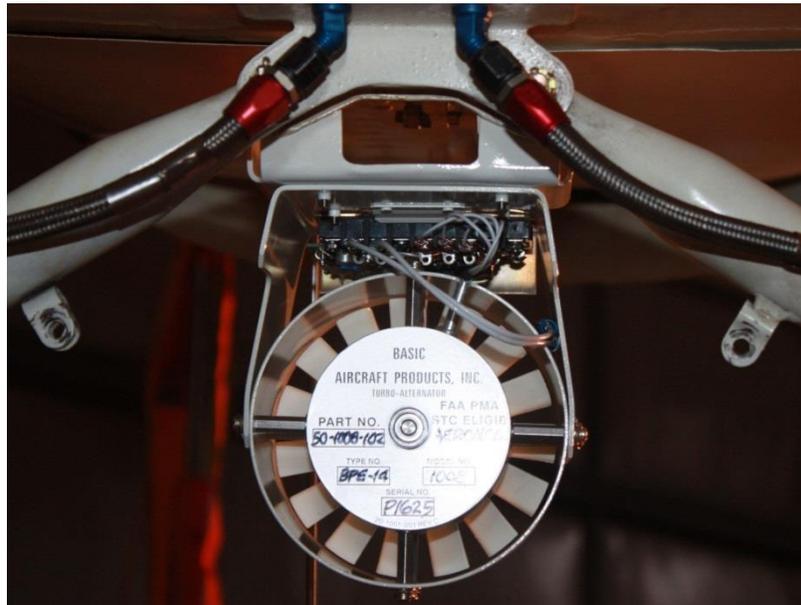
The picture below shows the alternator from behind the unit. The hydraulic brake lines are positioned behind the axles and enter the aircraft through a bulkhead located behind the axle attachment bracket.

The alternator voltage regulator is located within the mounting bracket above the alternator assembly.

The two loose wires coming out the back of the regulator are the positive and negative leads that go to the electrical system.

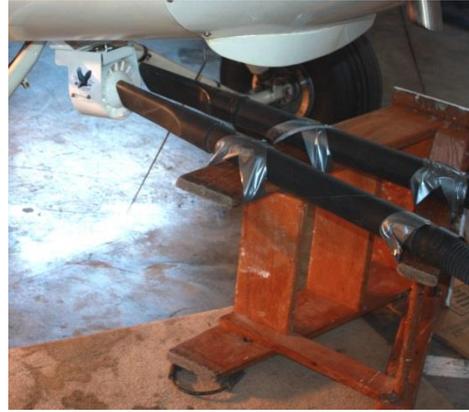
The initial test of the alternator consisted of mounting the discharge hose and nozzle from two large shop vacuums aimed at the BPE 14 alternator as shown in the photo to the right. The alternator circuit breaker was open and the master switch was off. When the vacuums were turned on, the alternator began spinning at a high rate of speed. A Fluke model 87 digital multimeter was connected to measure the output voltage of the alternator at the aircraft bus.

When the breaker was closed, the red master light came on. The voltage was 14.35 VDC and the ammeter read .4 amps.

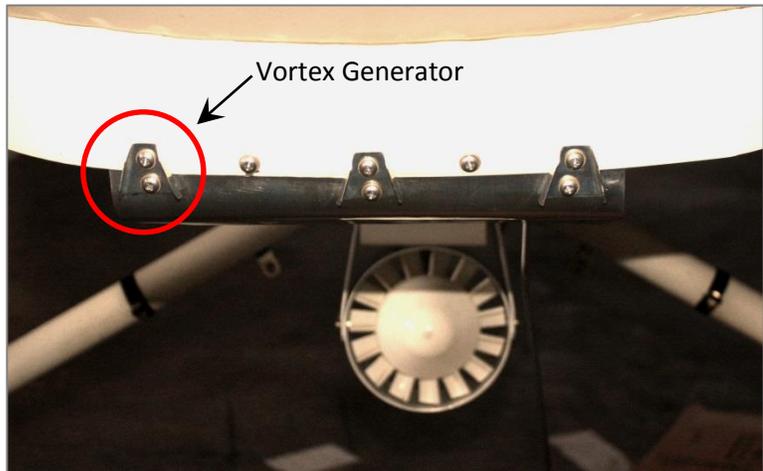
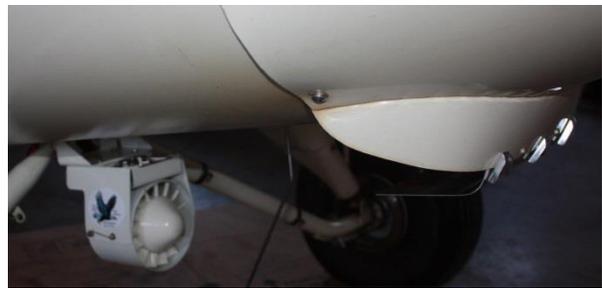
Based on reports by others, an air deflector was fabricated and installed on the bottom of the lip on the engine cowling as shown on the photos to the right. The theory is that the air deflector will aid in the diversion of air around the engine cowling lip to the alternator. The deflector was fabricated from .035" 2024-T3 aluminum, 6" X 9". Three pairs of miniature vortex generators were fabricated and attached to the leading edge of the air deflector. The deflector and vortex generators were attached with 6-32 aircraft screws and elastomer nuts. The leading edge of the deflector was bent into a smooth curve around a piece of 1" conduit. The trailing edge of the deflector was aligned with the top of the alternator.

With the deflector and vortex generators installed, flight tests confirmed significant improvement in the alternator output.

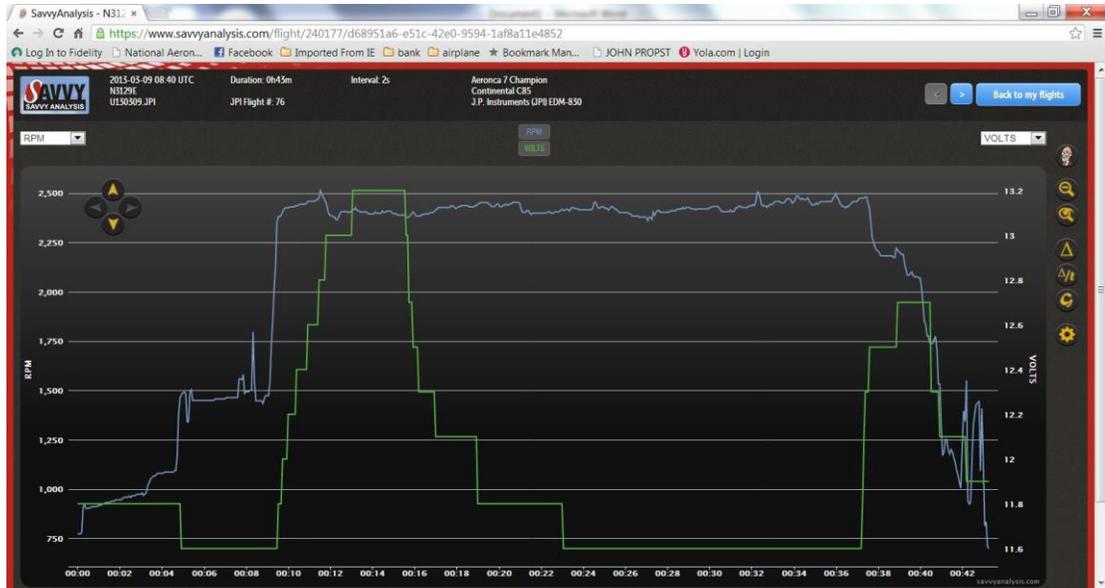
At six minutes into the flight I decided to open the circuit breaker in the alternator output. The output of course went to zero amps when I opened the circuit breaker. However, when I closed the breaker the alternator output remained at zero. I continued to fly. Over the next 21 minutes the alternator did not come on. The Bus voltage gradually decreased to 11.6 volts. When I keyed the radio announcing my arrival back at our airport the alternator came back on and operated normal. I recalled that yesterday when the alternator went off after I opened the master switch, it also returned when I keyed the mic on the radio. I am guessing that in both cases the radio transmission added a sudden load to the aircraft battery.

Hi John, yes, this is a phenomenon that has showed up in the last 2-3 years. What is happening is the high voltage cutoff voltage is set (fixed setting) not too far above the regulating voltage. The regulating voltage is normally set for around 14.5 volts, but when there is an open circuit on the load, the voltage increases upward somewhat. In some regulators, the high V cutoff point is not very much higher than the regulating voltage. When you open the CB, it allows the voltage to exceed the high voltage cutoff point. In practicality, there is no reason to ever open the CB in flight, other than to see what happens. If you want to do that, just slow the plane down until the voltage comes back on. It is just the nature of the regulator components. The tolerance on some components is maybe +/- 10%, and if the combination is just right, the voltage setting is too close to the regulating voltage. I think if you always leave the CB engaged, this should not happen. There is nothing wrong with the regulator.

This chart displays the voltage and RPM captured during the flight in which the alternator breaker was opened and then closed. Note the increase in battery voltage on takeoff (rpm increase). At around 15 minutes the breaker was opened and the battery voltage starts decreasing. At around 37 minutes the alternator begins operating again. Shortly after the alternator begins working, the aircraft lands.

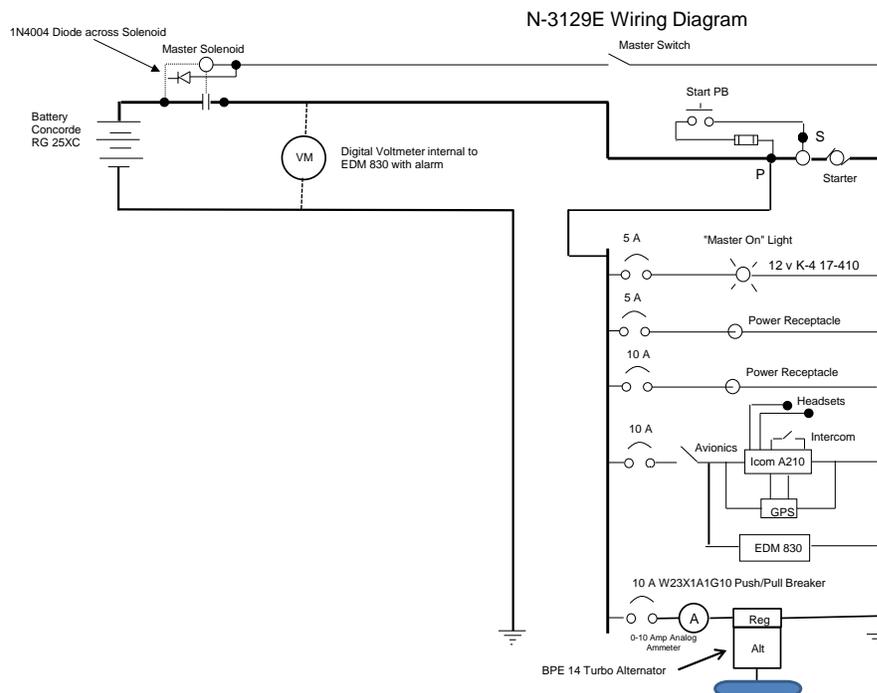
Electrical Schematic Diagram

The wiring diagram shown at the end of this article shows the hookup of the alternator. All wiring was completed with 14 gauge aircraft approved wire and approved crimp on terminations.

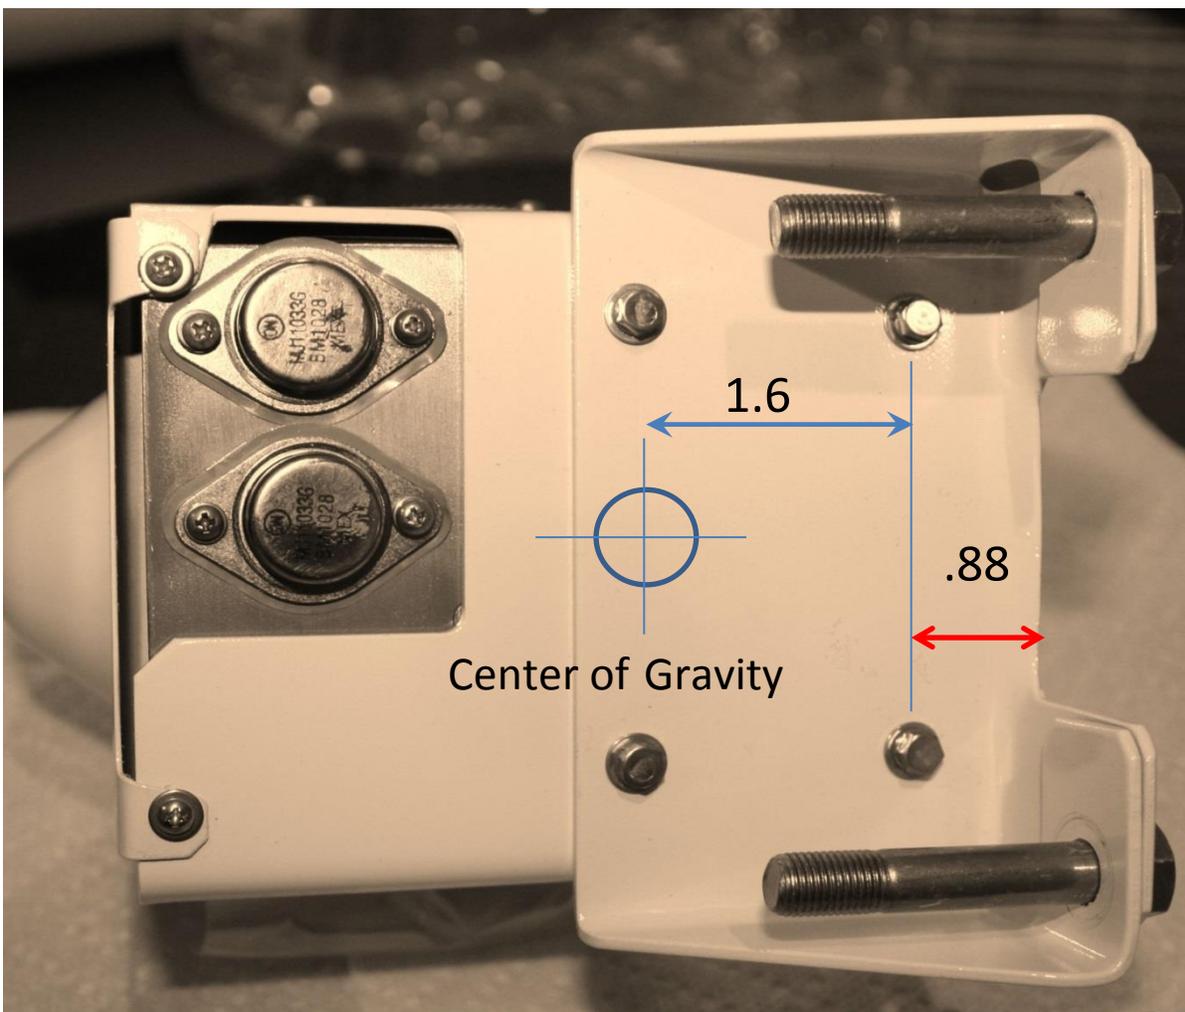
Weight and Balance when installed on an Aeronca Champ

The installation instructions for the BPE-14 Model 1008 alternator installed on a Champ indicates that the units center of gravity is located 1.6" forward of the aft mounting holes as shown below. The unit weight is listed as 4.0 pounds. As shown below, the aft mounting holes are .88" forward of the face of the mounting bracket. When using the wing leading edge as the datum for aircraft weight and balance calculations, the center of the aircraft axle is 1/4" forward of the aircraft datum. Based on dimensions shown on Aeronca drawings 1-2326 and 7-450, the front face of the axle attachment bracket is located 0.825" forward of the aircraft datum. Therefore the alternator assembly results in a weight of 4 pounds located $0.825" + .88" + 1.6" = 3.31"$ forward of the aircraft datum. This yields a moment of $3.31" \times 4 \text{ lb} = 13.22 \text{ in-lb}$.
