# Guidance for the Care of Aeronca Oleos

**Abstract** – This article provides suggested guidance for the routine inspection and maintenance of standard oleo struts on Aeronca Champs and Chiefs.

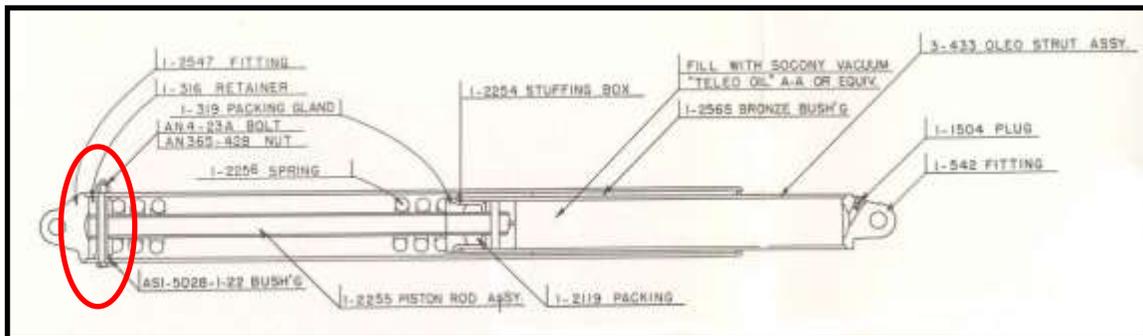
Figure 1

If one walks down the flight line at an Aeronca event, it is relatively easy to spot the subtle signs indicating that the aircraft's oleo struts have not recently, if ever, been removed for inspection or maintenance. The upper end of the oleo is held in the oleo case frame by an AN4-23A bolt, as shown on the left hand end of the figure 1 below. It is not uncommon to see this bolt covered either with paint or sometimes even fabric, indicating that the bolt has not been removed since the aircraft was restored.

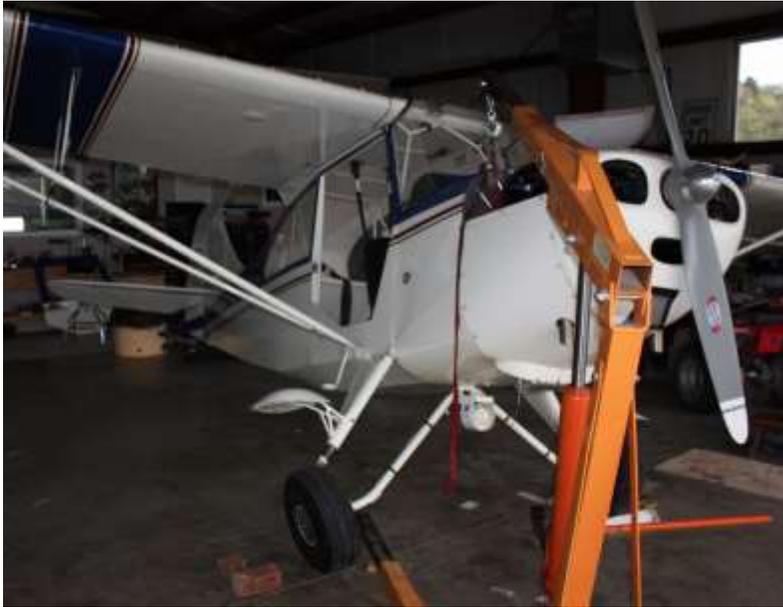
The first step is to lift the aircraft landing gear off the ground. While there are a number of safe methods for doing this, we used an engine hoist attached to the upper firewall engine mount attachment point as shown in the photo. In this photo the lower bolt attaching the oleo to the axle has already been removed. Depending upon whether or not the wheel is removed when inspecting the oleo will determine how high the aircraft must be lifted to

allow the oleo to swing past the tire, brake drum, or other obstructions.

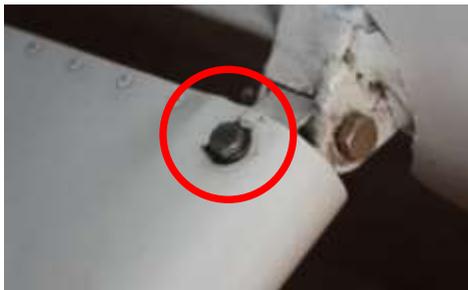
Next, the AN4 bolt at the top of the oleo case frame must be removed. (Shown in the red circle on the photo).

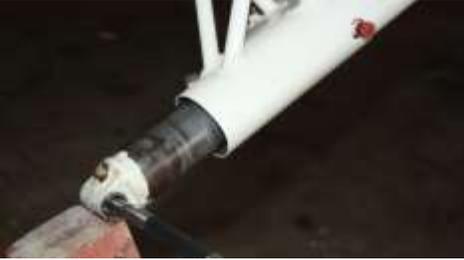
With the upper bolt removed, the oleo "should" just slide out the end of the oleo case frame. However, if you have not removed the oleo in a while, you may need to apply a bit of persuasion. As shown in

the photo on the left, insert a properly sized pin punch or bolt into the lower oleo attachment fitting and tap on it with an appropriately sized hammer, until the oleo eventually slides out the oleo case frame.

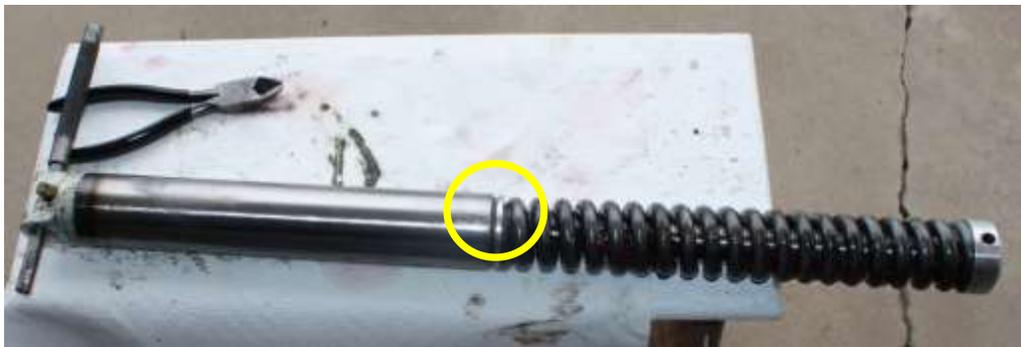
Once the oleo has been removed from the oleo case frame, it should be cleaned with varsol or other grease remover. The oleo should resemble the one shown in the photo below. The oleo body should be smooth and scratch free, indicating that it was properly lubricated and moved freely in the case frame brass bushing. The spring should not have any signs of rubbing on the case frame. One important detail to look for is the clearance between the packing gland and the top of the stuffing box. This is the gap shown in the yellow circle on the photo. The

spring pushes on the packing gland which in turn squeezes the packing in the stuffing box to create a seal between the

case and the piston rod. When the packing wears, the packing gland will gradually move closer to the stuffing box. When the two touch, the packing gland can no longer exert force on the packing and the oleo will begin leaking fluid. Without fluid, the oleo cannot function as a shock absorber and the oleo and landing gear will beat itself to

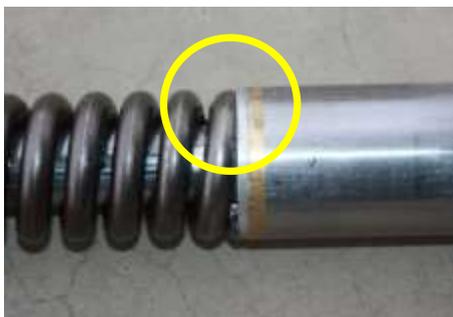
pieces. This next photo shows an oleo in which the packing gland has just come in contact with the stuffing box. When the fluid in this oleo was replaced, the fluid leaked pass the packing. If you have an oleo that is leaking fluid, this is the first place you should look. If the gap no longer exists, you need to either replace or add packing. This is a relatively easy task that can be performed in the average workshop.

When I came across this problem with the oleo shown in the photo, I called Bill Pancake to discuss the options for repair. Bill suggested that rather than replacing the packing, it is much easier to just add additional packing on top of the packing already in the oleo. Over time the existing packing has been form fit to the oleo and there is really no reason to disturb it. Therefore the following procedure and photos show the process used for adding packing to this oleo. The first step is to remove the spring from the oleo. There

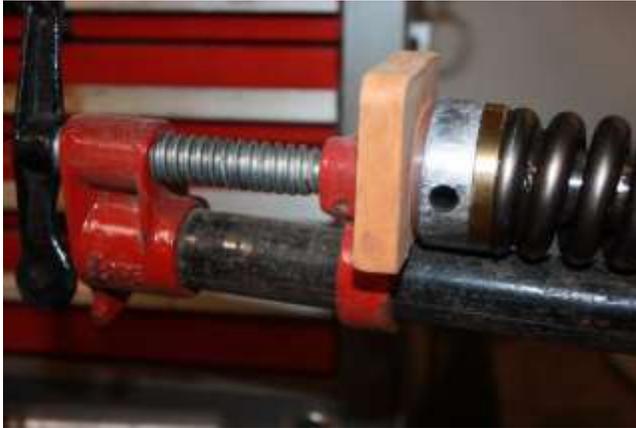
are a number of ways that this could be done. The method I chose was to use a standard pipe bar clamp and compress the oleo to remove the pressure from the hollow

pin and cap on this next photo. Use a 5/16" pin punch to drive the hollow pin from the cap. You may notice that this oleo has a 1/4" brass bushing on the end of the spring. The bushing was previously added to this oleo to help level the plane and is otherwise not related to this article. Once the hollow pin is removed, the clamp is loosened and the oleo is removed. This allows the cap and spring to be removed from the

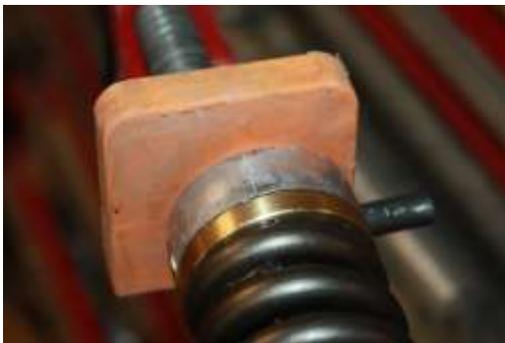
oleo piston rod. With the spring removed, you should be able to move the piston rod in and out and hear the fluid rush through the orifice in the internal assembly. It is now time to drain all the fluid from the oleo. To do this remove the 1/8" plug from the base of the oleo. Holding the oleo vertically, place the drain hole in a container. "Slowly" move the piston rod to push the fluid out of the oleo. Depending upon how often the oleo has been serviced the fluid may range from nice clean red brake fluid to black gunk. Caution that if you move the piston rod to fast the fluid will squirt all over everything. Once the fluid has been removed, slide the piston all the way down to the drain hole. With a flashlight, look in the drain hole

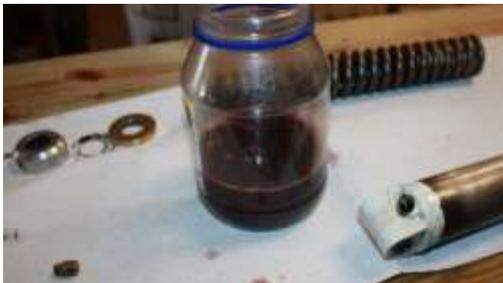
and verify that the oleo has an aluminum rather than micarta piston. You should never reinstall an oleo that has a micarta piston. The piston should be replaced. That again is a job that is beyond the scope of this article. Once the fluid has been removed from the oleo, extend the piston rod and inspect the surface. It should be smooth and shiny for the first 3 inches near the packing gland. If it isn't, the packing will not seal against the shaft. The piston rod can be replaced, but again that is a task that is beyond the scope

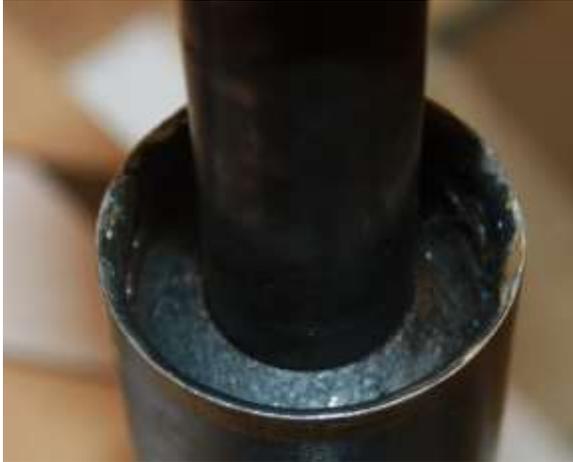
of this article. Now the packing gland can be slid back from the stuffing box as shown in this photo. The packing gland fits very loosely in the stuffing box so it should be easy to slide. If the packing gland is damaged, they are available from Univair.

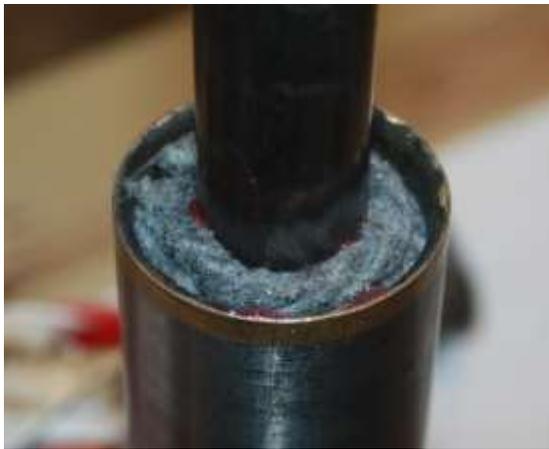
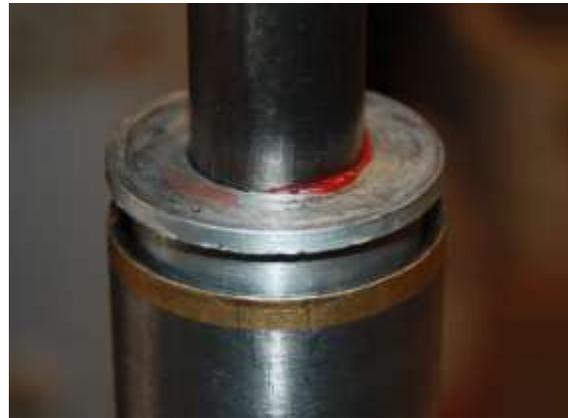
With the packing gland slid back, you should now be able to view the existing packing in the oleo as shown in this photo. If the existing packing appears to be in good condition as the packing in this photo does, there is no need to remove it. Additional packing can be added on top of it. Graphite faucet stem string packing is available from most hardware stores and plumbing shops. My local hardware store carried "Do It" brand packing. The

container was labeled as 3/32" X 24" (#402254). The intent is to add enough packing so that when it is totally compressed it will result in about a 1/8" gap between the packing gland and the face of the stuffing box. It is somewhat trial and error to get an adequate amount of packing added. The

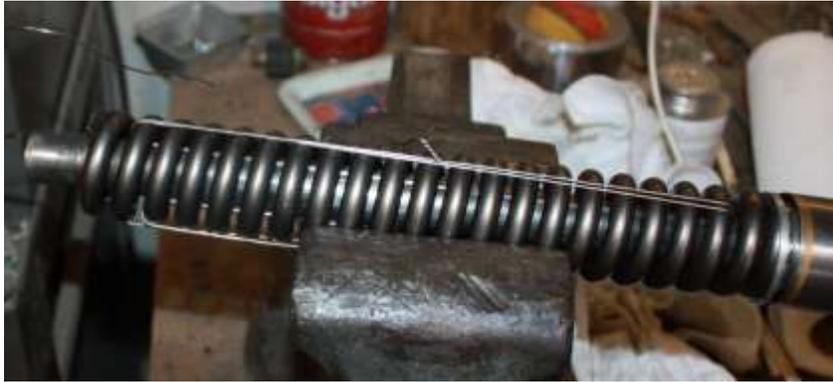
packing was compressed with the spring, the packing gland was again slid back and an additional wrap of packing was added. It would be easy to say that now all you need to do is reinstall the spring over the piston rod, install the cap and the hollow pin, but the task isn't quite that easy. In order to reinstall the cap, the spring must be compressed and the piston rod must be pulled up through the spring. I asked Bill how he did this and

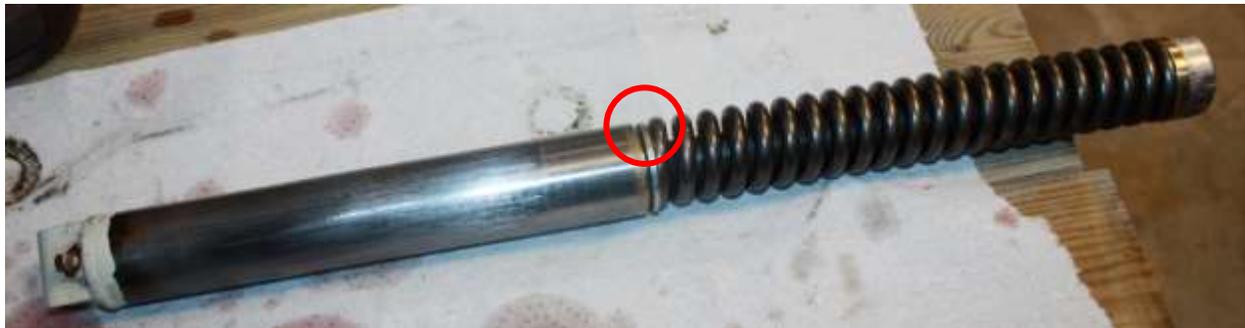
compressed and safety wire is used to hold it in the compressed position while it is

installed on the oleo. The spring is compressed about an inch in the bar clamp and .040 safety wire is fed from end to end on the spring and tightened to hold the spring in the compressed position. Three loops of safety wire are equally spaced around the spring to hold it straight. A single piece of safety wire is then attached to the end of the piston rod and is used to pull the piston rod through the spring. The cap and hollow pin are then replaced in the end of the piston rod. The oleo is again placed in the bar clamp

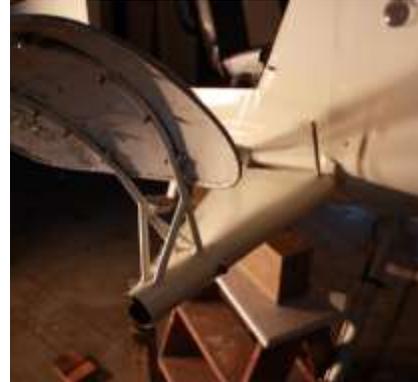
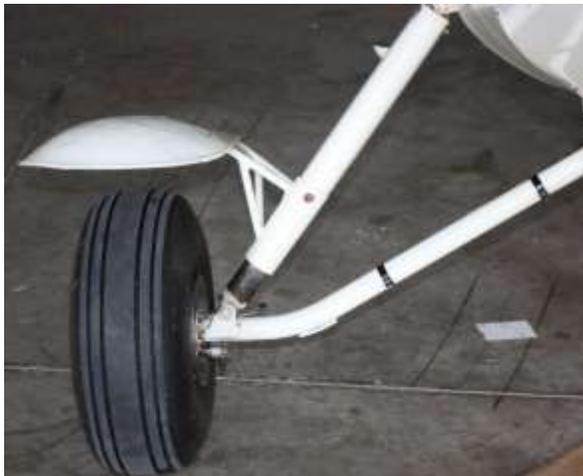
to compress the spring and remove the tension from the safety wire. With the wire tension relieved, the safety wire can be removed. The photo above shows the oleo reassembled. Note the gap between the stuffing box and the packing gland.

The last step is to refill the oleo with fluid. I use Aeroshell #41 red brake fluid in my oleos. There are other approved fluids available. I use a small pumper oil can with a plastic tube on the end to fill the oleo. I stand the oleo on end with the filler hole at the top and pump in fluid until the unit is completely full. I then tap and shake the oleo a bit to get the air bubbles out and top it off again. After the oleo is full, the fill plug is reinstalled. Installation of the oleo is basically the reverse of the process used for removing it. The upper hollow pin in the oleo is aligned vertical and the oleo is slid back into the oleo frame. It should slide in very easily. You may need to wiggle it around a bit if the packing gland hangs up on the oleo frame bushing. A small pin punch or small screwdriver should be placed in the upper hole on the oleo frame so that you can tell when the oleo comes in contact with the pin or screwdriver. The pin or screwdriver is then removed and the oleo is inserted another 3/8" or so until the hollow pin aligns with the holes in the oleo frame. Make absolutely certain that the AN4 bolt actually passes

through the hollow pin in the upper end of the oleo. Once the upper bolt has been reinstalled, the oleo can be swung down and the bolt between the lower end of the oleo and the axle can be reinstalled. A cotter pin should be installed in the oleo to axle bolt and if appropriate, the fill plug should be safety wired. The plane can then be lowered. The plane can be rocked back and forth and no fluid should be leaking from the oleo. Three or four pumps of grease should be applied to the grease zerk on the oleo. It is important to
