Installation of BPE-14 Wind Powered Alternator on Aeronca Champ

By John Propst with Technical Review by Bill Pancake

Abstract: this article covers the installation of a BPE-14 Wind Powered Alternator on a 1946 Aeronca Champ.

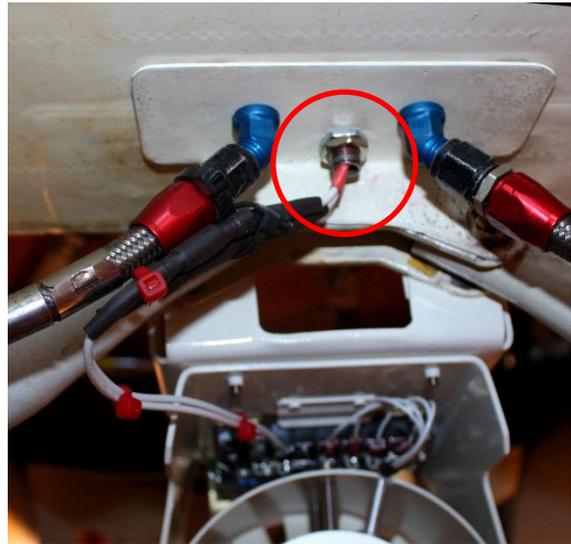
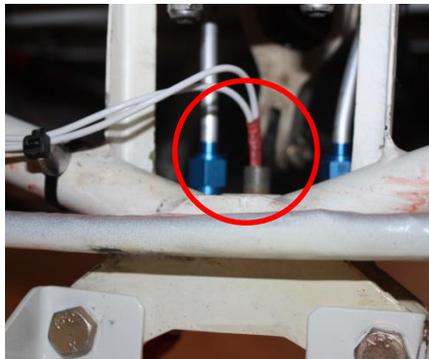
and a female crimp-on splicing connector on the negative (-) lead. Mating crimp-on connectors were installed on the power leads going from the alternator to the aircraft electrical system. Heat shrink tubing was then installed on each individual splice connection. In the area where the two power leads pass through the bulkhead thru fitting, additional shrink tubing (red) was applied over the two wires. The leads were then positioned and ty-wrap secured. The picture below shows the two power leads exiting through the top of the bulkhead thru fitting. The negative lead is then routed to the aircraft ground bus located on the engine side of the firewall. The positive lead is routed to the + terminal of the panel mounted 0-10 amp DC ammeter. A 10 amp push-pull aircraft circuit breaker was mounted on the aircraft

panel next to existing breakers. A power lead was then installed from the negative terminal of the panel ammeter to one side of the circuit breaker. A short lead was then installed from the other circuit breaker terminal to the positive aircraft bus bar, located on the other four aircraft circuit breakers.

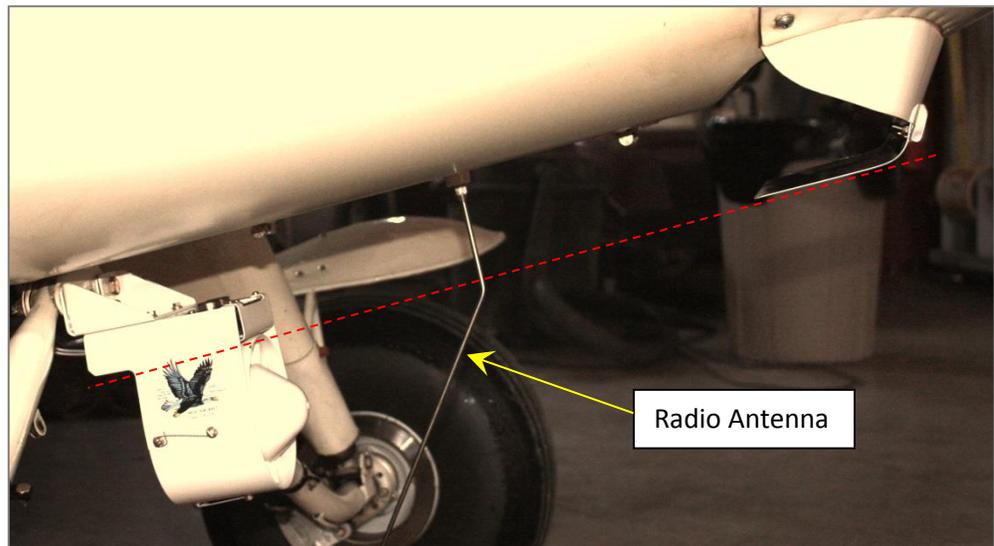
With the deflector and vortex generators installed, flight tests confirmed significant improvement in the alternator output.

Before installing the deflector, the ammeter would not move off of zero until after takeoff and about 60 mph. With the deflector, the ammeter began to move off zero at about 1500 rpm.

At takeoff the battery voltage was 11.6 volts. After takeoff the battery voltage rose steadily to 13.6 volts.
