Aeronca Oleo Strut Maintenance

First Section Original Material by John Baker
This Article Assembled and edited by John Propst
Technical Review by Bill Pancake

Abstract: This article covers the inspection, maintenance, and overhaul of oleo struts used on Aeronca Chief and Champ aircraft. The primary focus is on the standard struts although there is some additional information related to the no-bounce struts.

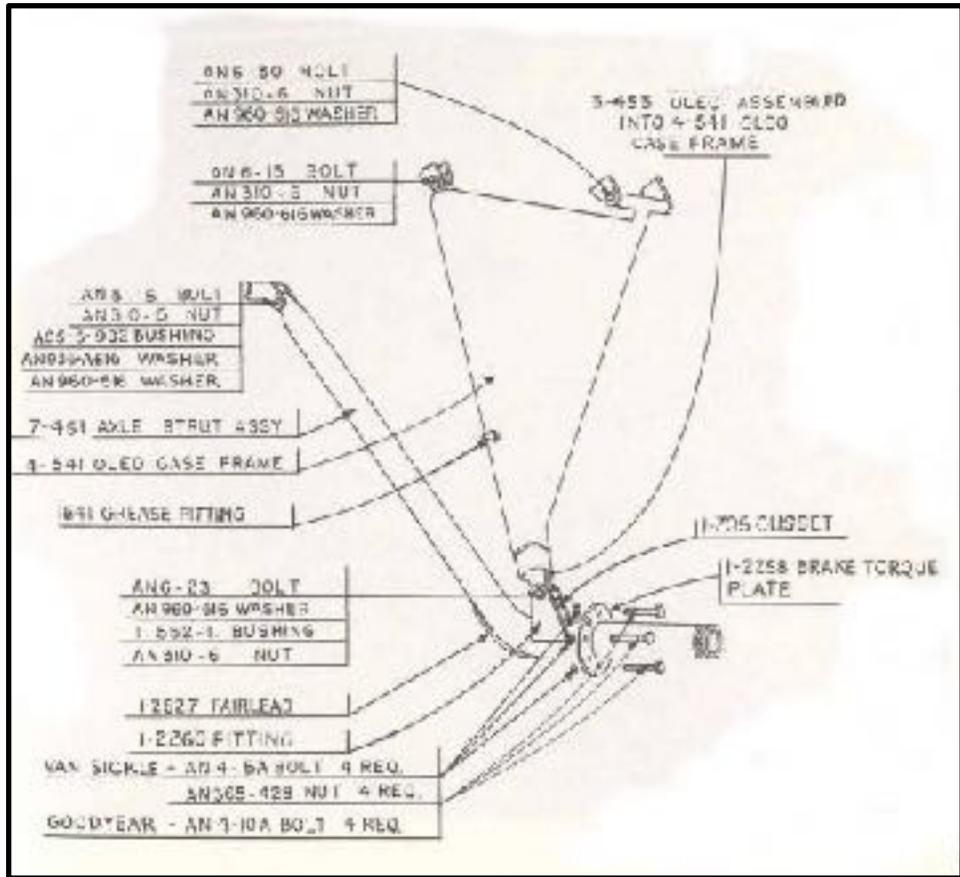
This figure displays the Aeronca landing gear major components. This "Landing Gear Drawing" was extracted from the Aeronca Champ Service Manual

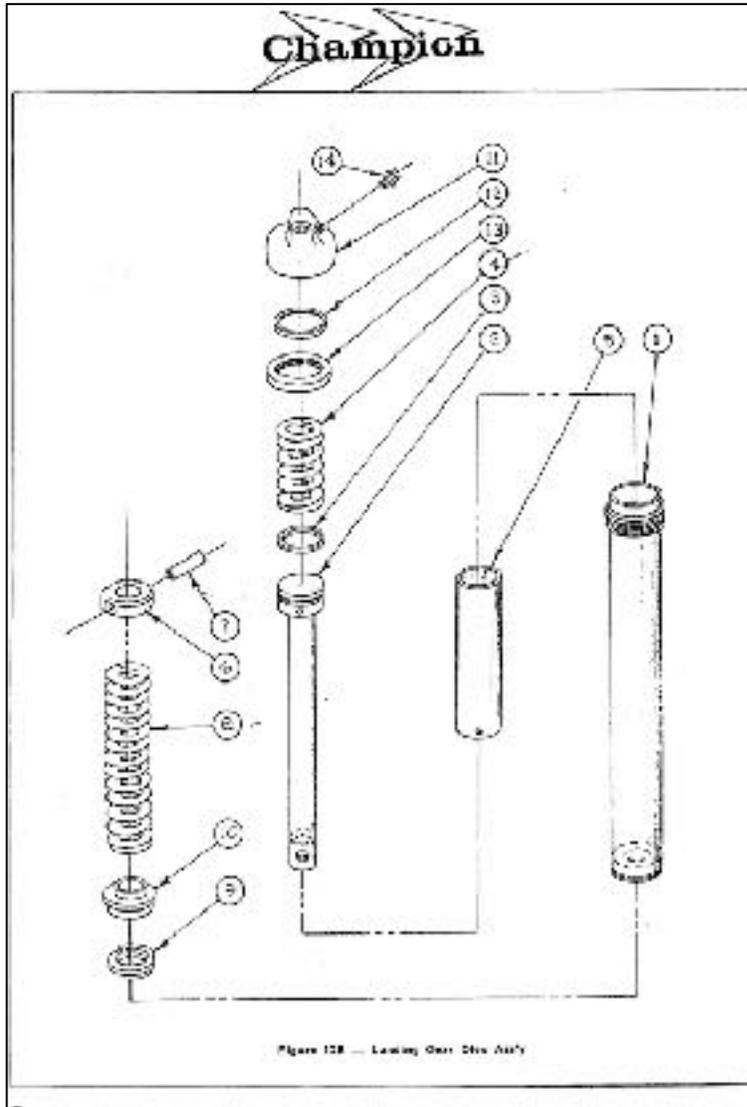
oleo strut, a hydraulic device used as a shock absorber in the landing gear of aircraft, consisting of an oil-filled cylinder fitted with a hollow, perforated piston into which oil is slowly forced when a compressive force is applied to the landing gear, as in a landing.

I admit I've applied some extraordinary "compressive forces" to the landing gear on my Chief. It's a great landing gear, but it does need regular maintenance. And after 60 plus years, there are some things to look for. I knew that the oleo struts on my Chief had been rebuilt with new bushings just three years prior, but even so, not all was quite as it should have been. What follows is based on my experience. It should help you understand how the oleo struts are put together and serviced. Before you tackle your struts, read this entire article - because what follows does not necessarily proceed in step-by-step order. You should also carefully read the Aeronca Service Manual. All work should be performed or supervised by an FAA certified airframe mechanic, and the proper logbook entries should be made. One more note: the material here applies only to the **standard** oleo strut landing gear, not the "**no bounce**" landing gear offered later and found on some Aeroncas. Among other differences, the "no-bounce" gear uses a different, longer but smaller diameter spring that will not work properly in the standard strut. The "no-bounce" landing gear can be identified by a "bulb" located at the lower end of the oleo strut assembly. The figure on the left displays the no bounce gear. And the table below lists the no bounce parts list.

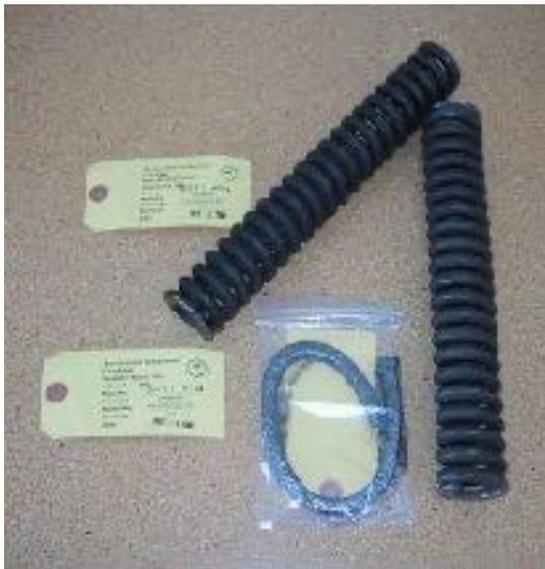
Since the bushings on my struts had been replaced when the plane was rebuilt in 1998, I did not replace those. My oleo struts were tight in the case frame, with little or no play. If things are loose, you may need new bronze bushings (part number 102565). I understand that these bushings can be difficult to remove, and often must be cut out.

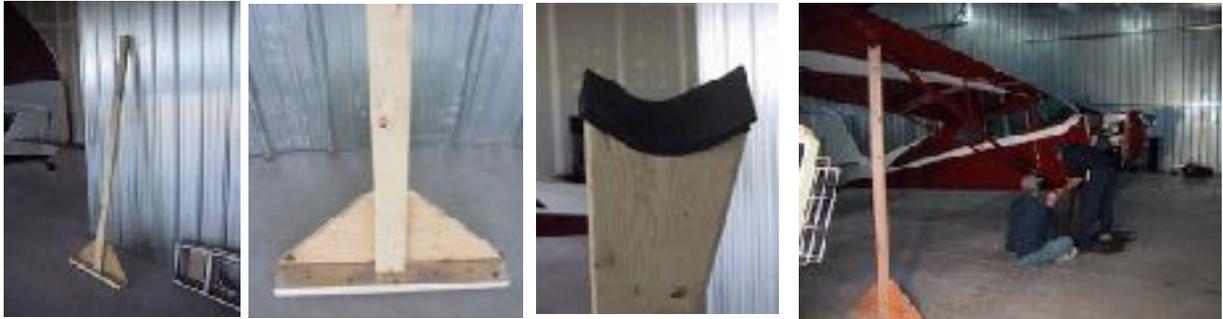
- I chose method three, a fixture (that I'll call a wing jack) to support the wing at the wing strut attach point. Since I would be working in a hangar with no wind, I felt this was safe. I also planned the work to minimize the amount of time the wing was lifted. I built the wing jack from 2x4's and

plywood, as shown in the photos. I used a vertical 2x4 83" tall with a base 24" wide, gusseted with plywood, all glued and screwed together to make a sturdy, inverted "T". Where the vertical 2x4 supports the wing, I cut a concave section out to support the strut, so the strut could not slip off the top of the 2x4. I used a few pieces of rubber tape for a non-slip, non-scratch surface. The photos tell the story best.

I made my lift 83" tall, which lifted the tire off the ground just a few inches. I suggest a slightly taller lift, perhaps 86" or 87" for a Chief. I'll explain why later. A lift for a Champ would need to be even taller. To lift the wing, first place wheel chocks on the opposite side main wheel and tailwheel. Then have one or two strong lifters lift the strut, just a few inches inboard of the tie down ring. While the strong guys lift the wing, you (the smart one) slide the wingjack into position, just inside the tie down ring and strut fitting. Set the wing carefully down on the wingjack, with the base of the wingjack squarely on the floor and the vertical 2x4 in a truly vertical position. This arrangement worked out just fine for me, but I would not recommend doing this outside where a breeze could upset things.

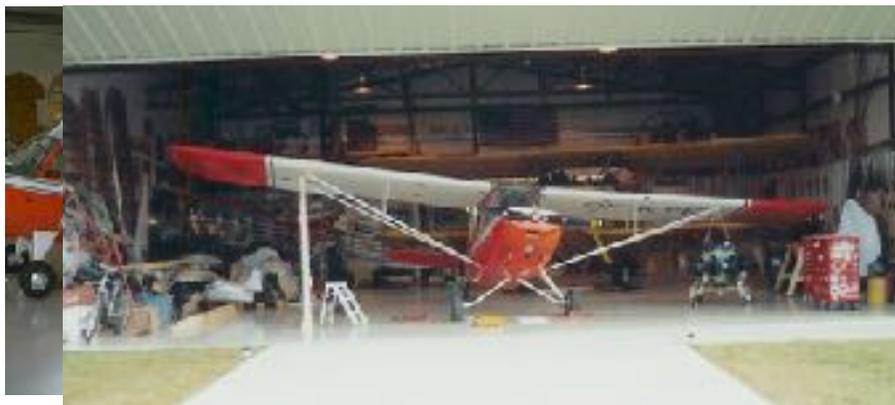
Here's another variation on the same theme, this arrangement by Dan Jones from Alberta, Canada. He actually used a combination of methods two and three. It helps to have a spare Continental W670 radial lying around the shop to use as "dead weight". Dan explains:

"The A frame trestle is 2x4's bolted together for stiffness and it's the absolute bare minimum height for a Champ, 87" from the apex of the saddle to it's base. You can't swing the gear leg out - I opted just to remove the case frame completely - my logic being that the lesser the angle I had to trestle the airplane at, the less load I'd put on the other gear leg and it's packing. I jack the airplane with a small jack and then slip the trestle in place and lower the airplane down onto the free standing trestle. Then I use a heavy weight (I used a time-expired W670 Continental) tied down to the low wing's tie down point in case the trestle slips. It's all very easy to do solo."

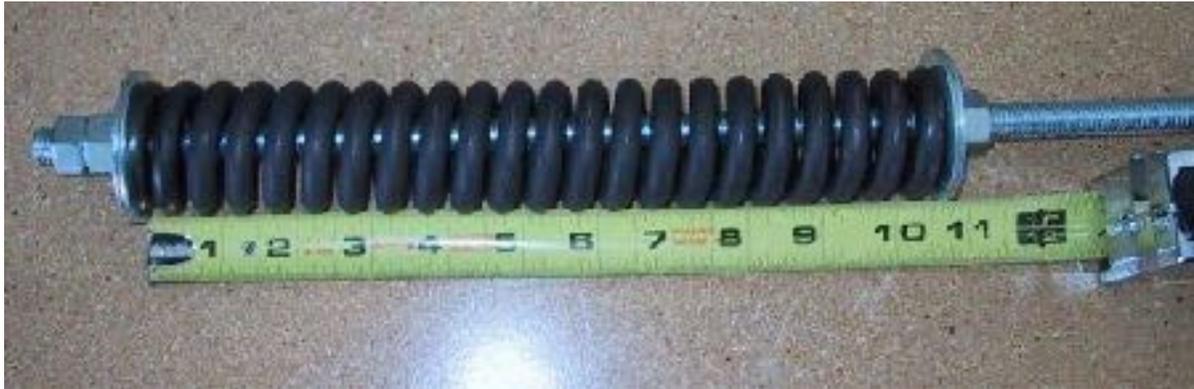
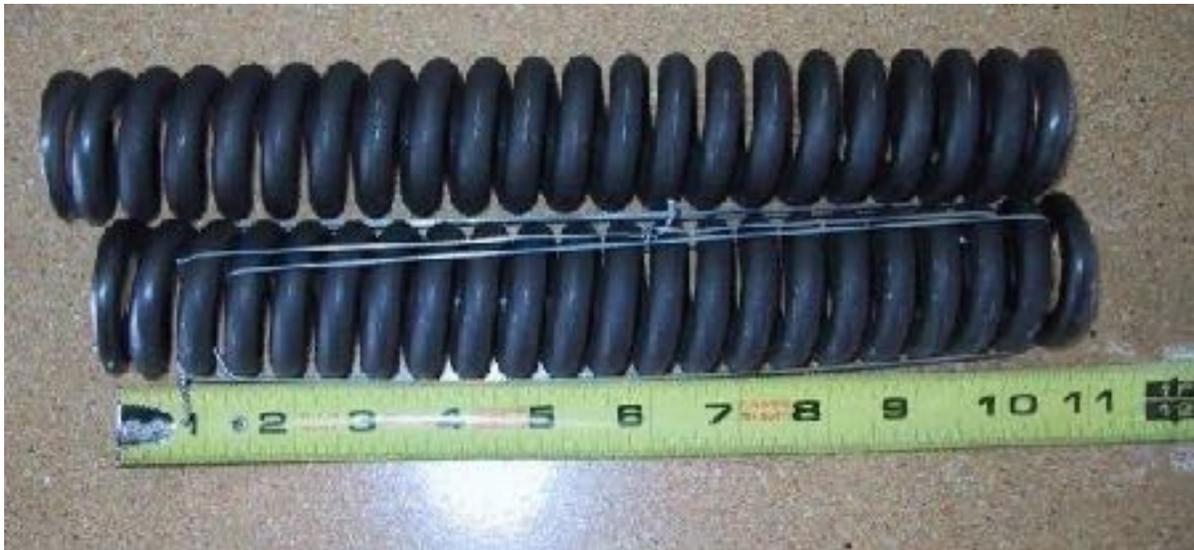
received were 11-1/16" tall. To fit them on the strut you will need to compress them to about 10-1/2". The method I used successfully was recommended by Aeroncater Richard Jeffryes. It worked great. I went to my local hardware store and bought a half inch threaded rod, 2 feet long, with nuts and washers. I ran the

rod through the new spring, with a nut and washer on each end. After tightening the nut so that the spring was compressed to about 10-1/2", I used safety wire wrapped though the coils to hold the spring in the compressed state. Then I loosened the nuts and removed the threaded rod. Cool - I now had a shorter spring that I could fit onto the strut piston rod with no pain. The first photo below shows the spring compressed using the threaded rod. The second photo shows one spring "au natural" and the second held in the compressed state with safety wire. I used a safety wire in three different places around the circumference of the spring. The old spring that I removed was 10-1/2" long, 9/16" shorter than the new spring. Richard Jeffryes has measured a couple of new springs and they were 11-1/8" tall.

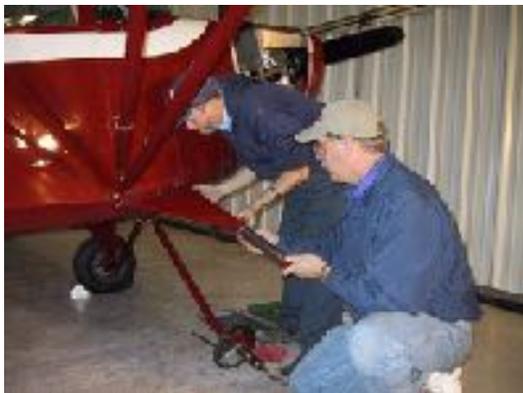
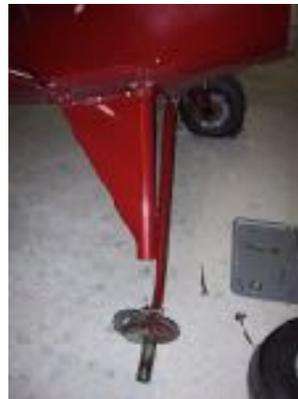
In the photo below, I pull the oleo piston assembly out of the case frame, while my friend Tom Crone supports the case frame. Or maybe I'm putting the strut back in. Hard to tell. On the right, the empty case frame.

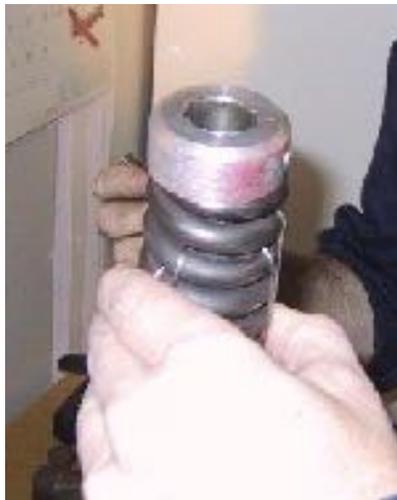
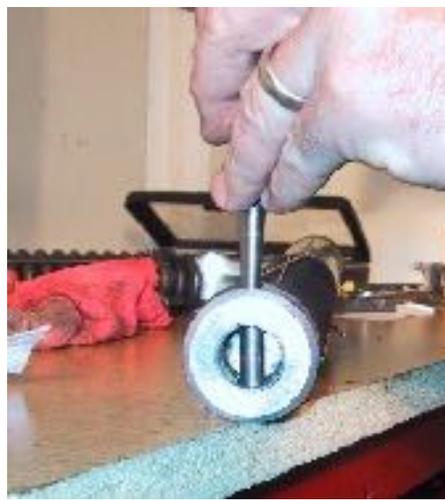
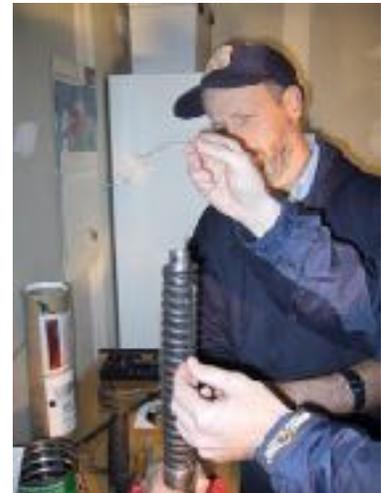
At the top of the assembly there is an aluminum retainer (part number 1-316) that holds the spring in place. It is attached to the piston rod assembly (part number 1-2255) by a bushing (ASI-5028-1-22) that is driven through the retainer and through the piston rod. Once the assembly is back in the case frame, the AN-4-23A bolt that you removed earlier will go through the case frame, the retainer, the piston rod, and the bushing to hold the entire mess together. To remove the spring, you drive out the bushing. Use a punch or pin that is just under the diameter of the bushing, being careful not to damage the bushing, since you will reuse it. Once the bushing is driven out, the retainer can pop off and you can remove the spring. Assembly works just the reverse, after you installed the compressed spring as shown below. It works best if you take a file and create a slight taper on the edge of the bushing before reinstalling. We found that the piston rod wanted to slide back into the strut cylinder while we were installing the spring. To pull the piston rod back to its fully extended length, we simply tied a piece of safety wire to the top where the retainer and bushing is attached, and used the safety wire to pull the piston rod to the extended position. Then we were able to easily slide the retainer onto the end of the rod.

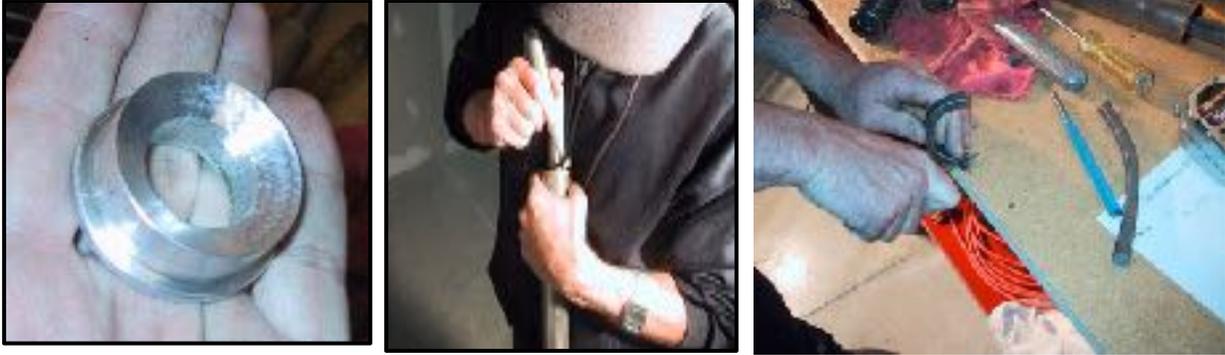
The photo below on the left is of the aluminum packing gland, bottom side up. It sits on top of the hydraulic cylinder, held in place by the big spring. The beveled shape forces the packing against the piston rod to minimize seepage of the hydraulic fluid around the rod. In the center photo, the packing is partially installed in the stuffing box and Tom is using the knife to mark the packing for final cutting. In the photo on the right, Tom is trimming a piece of packing at a 45 degree angle. David Rude says the new packing are not the same size as the originals and will wrap three turns instead of two as shown on the old drawings.

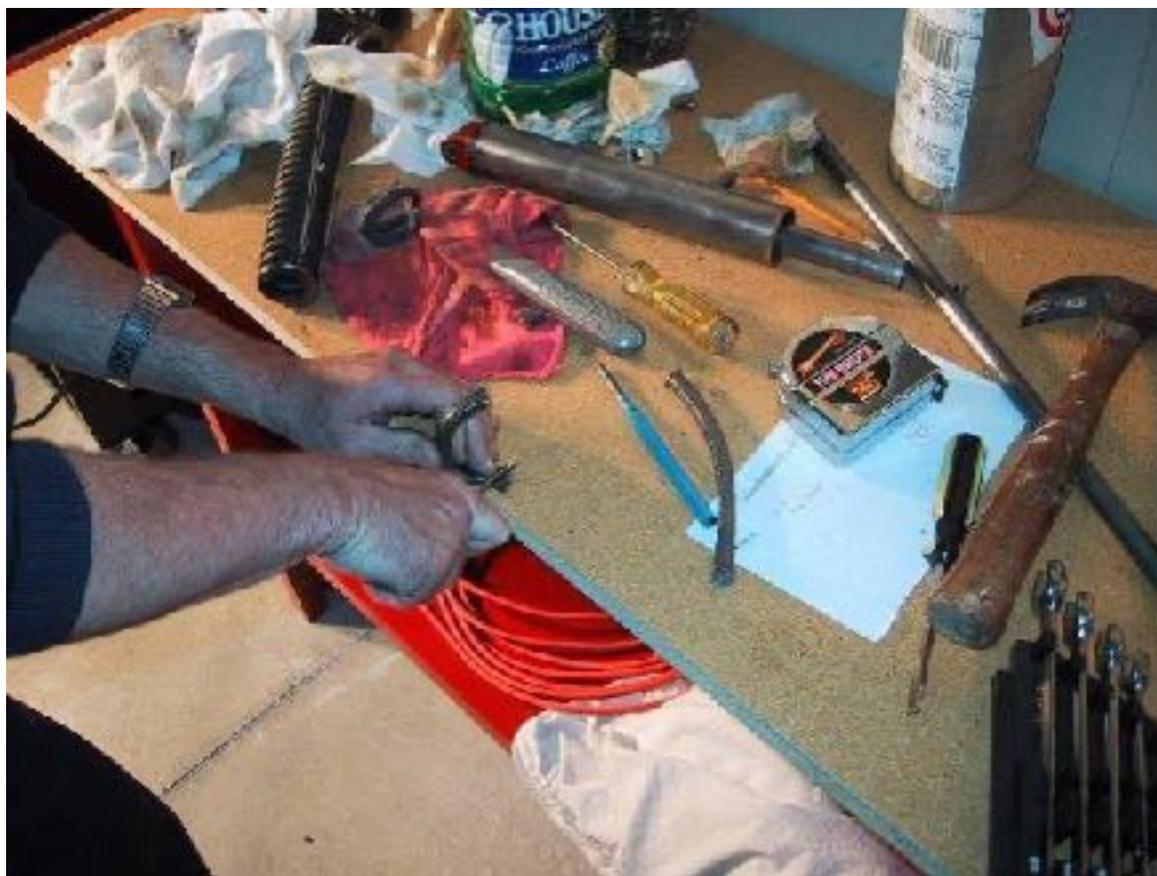
The workbench photo shown below is full of interesting things, and I'm not talking about the dirty shop rags. First, notice the coffee can. That's important; because you need to drain the hydraulic fluid before you pull pry the packing gland off. The plug is at the bottom of the strut. Unscrew the plug over the coffee can and let it drain until empty, more or less. On the left you see the new spring ready to install, compressed and held tight with safety wire. That's Tom with a knife cutting a 45 degree angle on the other end of the graphite packing, so that the packing overlaps. The hammer was used to flatten the packing a little so it fit in place better. Another piece of packing, more than enough for the second strut, is lying nearby. The blue handled punch and the yellow handled screwdriver were helpful for pressing the packing into the stuffing box, a cup-like area at the top of the cylinder. In the background, you can see the oleo piston assembly, with the spring and retainer removed, and the piston rod pulled only about one third to half way out of the cylinder.

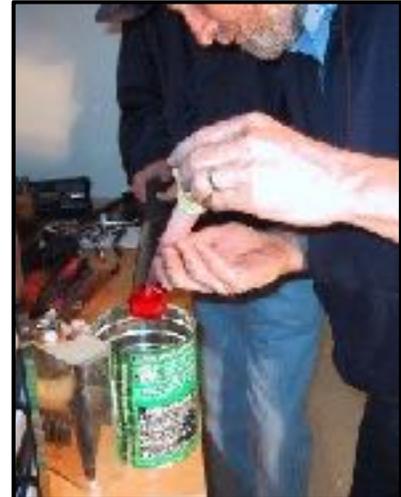
It's important that the strut is filled COMPLETELY with fluid. Lift the strut high enough so that it can be completely filled. An Aeronca Service Letter (#40, September 8, 1948) included the following information: "The landing load factor runs extremely high when the fluid gets low in the oleos - 3/4 full is almost as bad as no fluid at all! Oleos must be kept full of fluid." After filled, of course, screw the plug back in nice and tight. The photo below shows us filling the strut. We used a turkey baster for the job. It worked great. For those of you who may have seen instructions to fill the strut with 8.5 ounces of fluid, you should know that that instruction applies to the "no bounce strut", not the standard strut. If you have the standard strut, fill it up! By the way... there have been reports of major damage to the oleo assemblies from lack of oil. Some Aeronca owners have reported that the upper retainer will "mushroom" from the pounding it receives if the strut does not have enough oil. If this happens, repairs are difficult and expensive.

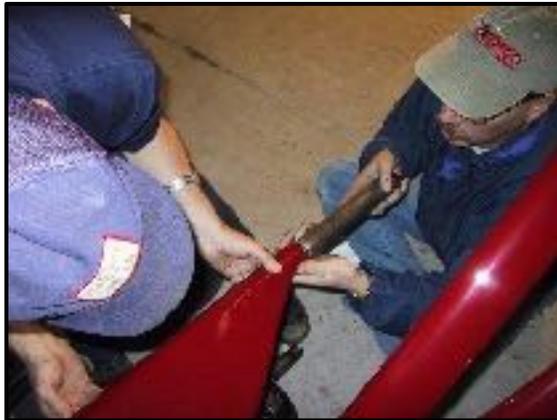
With everything back together, look for the Alemite (Zerk) grease fitting on the front lower end of the oleo case assembly. The Chief Service Manual says to apply AN-G-3a or AN-G-15 grease (apparently no longer available) with a gun until it is forced out of the bottom of the oleo case assembly. I just used the general purpose water-resistant grease that was in my grease gun. If you want to buy aviation grease, Aeroshell 22 or Aeroshell 6 would be appropriate. On the lubrication chart published by Shell in 1948, they indicate Aeroshell Grease 6 in the Aeronca Oleo Assembly Piston. Carl White says he does not trust the Zerk fitting to lubricate the full circumference of the strut, and instead gives the strut a light coat of grease before installing it (after carefully cleaning the case). Carl also suggests lightly coating the spring. Don't get carried away with the grease gun - a few shots should do it if you have given the strut a light coat of grease before installation. I heard a story of someone using two cartridges of grease with an air-powered grease gun. In this case, the grease found its way up into the spring area, completely filling it, and eliminating all chance for the strut to work properly. So... don't take at face value the instruction in the Service Manual to apply grease "until it is forced out of the bottom of the

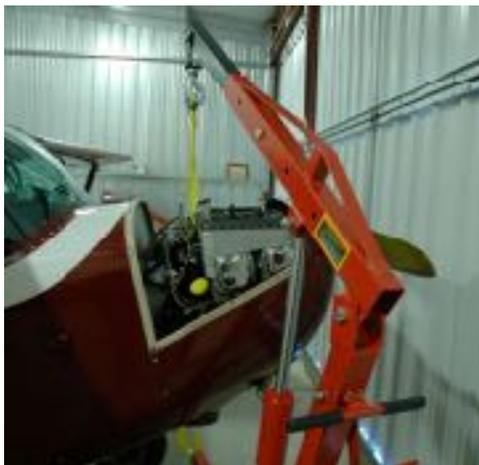
While waiting for the new parts, I stopped at my local John Deere dealer and picked up a gallon of Hy-GARD hydraulic oil. Part number for this oil, promoted as a multipurpose "Transmission and Hydraulic Oil," is TY6354 for the gallon jug. Cost for the gallon was \$7.77, a bit less expensive than buying MIL 5606 by the quart from the aircraft supply houses. The parts came from Wag Aero quickly, but I procrastinated about doing the work. Finally, a month later in October, 2005, I got to work. I decided to use a hoist (also called a shop crane) this time, and found one on sale at my local Harbor Freight store. Seemed like a good investment, since I will use it often enough. This made the job much easier, and enabled me to do the job "solo". I used a heavy duty nylon "tow strap" that I picked up at the local hardware store. After fretting about this, my friend Claudio tied a nice double knot in the strap to shorten the working length to about two feet. I slipped this under the engine mount tubes where the mount meets the engine. To help stabilize the aircraft, I chocked the tail wheel. I also used a tie-down strap between the opposite wing tie-down ring and a heavy stationary object on the floor (my air compressor served the purpose) to help keep the opposite wing low and to further stabilize the airplane when hanging from the hoist.

This method of lifting the aircraft worked great and I was able to lift the plane high enough that I could swing the strut out without removing the wheel assembly from the axle. Since the packing had been recently replaced and was well seated, I decided not to replace the packing this time, but simply replaced the spring with the new one. Again I used the safety wire method to compress the spring. Everything came apart and went back together easily and quickly. I drained the old hydraulic fluid from the strut and replaced it with John Deere Hy-GARD hydraulic oil. I cleaned out the case and spread a layer of grease on the strut before reinstalling. After five shots with the grease gun, I was good to go. Measuring the distance from the floor at the wing tips, the plane was once again "on the level."

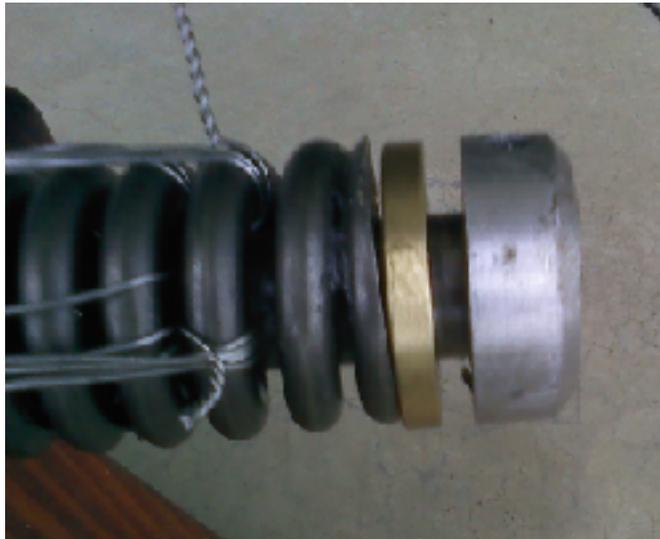
attachment point to wing spar attachment point likewise revealed no problems. The issued was discussed with Bill Pancake. Bill's feedback was that no matter how careful we are at trying to match the left and right sides of the aircraft, sometimes they just end up listing one way or the other. One method for correcting this problem is to make the effective length of the oleo spring on the low side of the aircraft longer by inserting a spacer between the oleo spring and the upper end retainer. The photo on the left shows the brass spacer that was fabricated to raise the low wing. It was somewhat a guessing game to decide how thick the spacer should be. The lower wing tip was about 3" lower than the higher wing tip. When the lower wing was raised until it was level with the higher wing, measurements of the oleos suggested that a 1/4" spacer would come close to correcting the problem. As shown in the photo, the spring was compressed and secured with three multiple wraps

of safety wire located equally spaced about the spring. Note that three single loops of .041 safety wire were not adequate to keep the spring compressed. After reassembly and reinstallation of the oleo strut, the aircraft now sets relatively level.

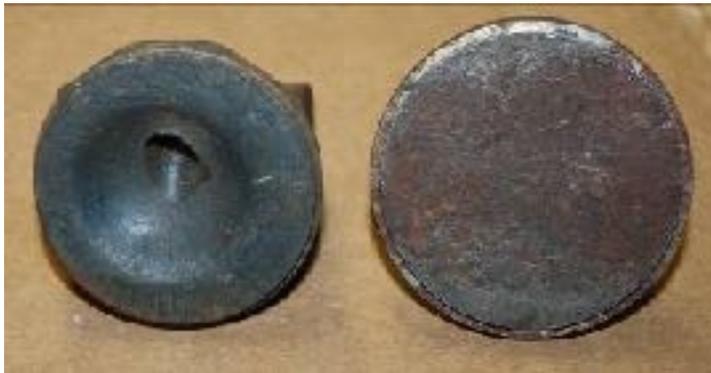
These two photos show new forgings that were used for the assembly of oleo struts. Note that the left forging is drilled and tapped for the fill plug.

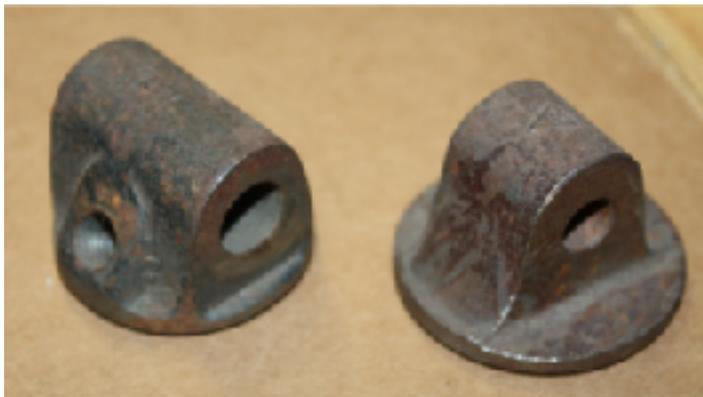
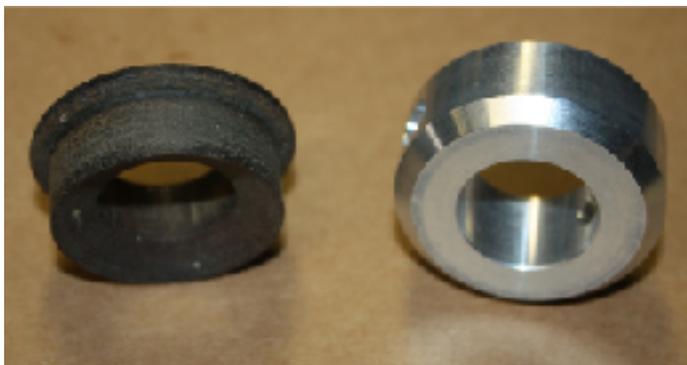
The photo on the left shows an old fiber packing gland and a new aluminum retainer. From this photo and the next few photos, note that there where three different components originally fabricated from fiber (micarta) and later fabricated from aluminum.

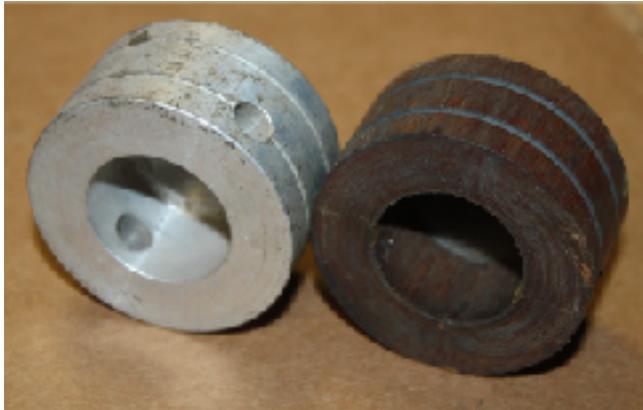
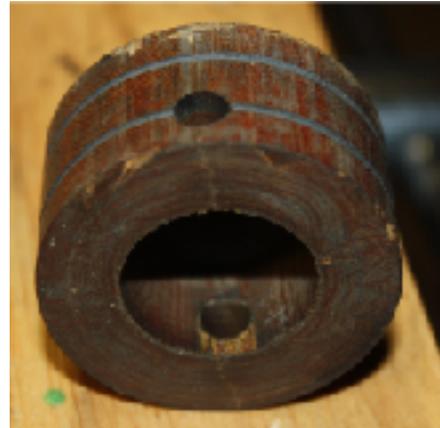
The photos below show both an aluminum and fiber piston. Note the cracks in the fiber piston shown on the right.

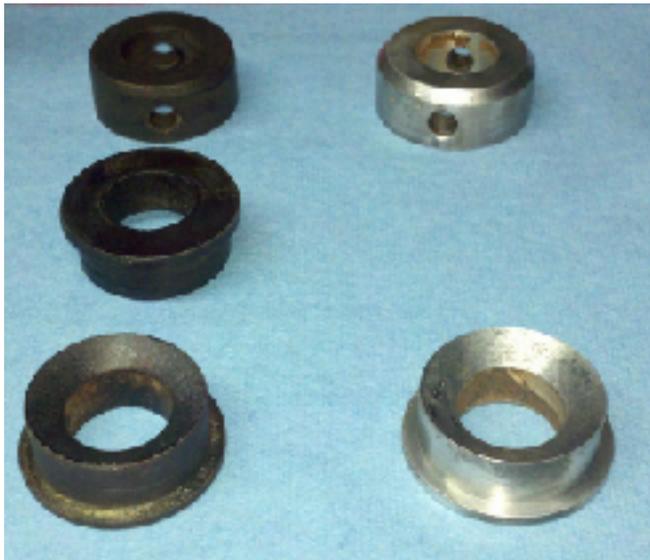
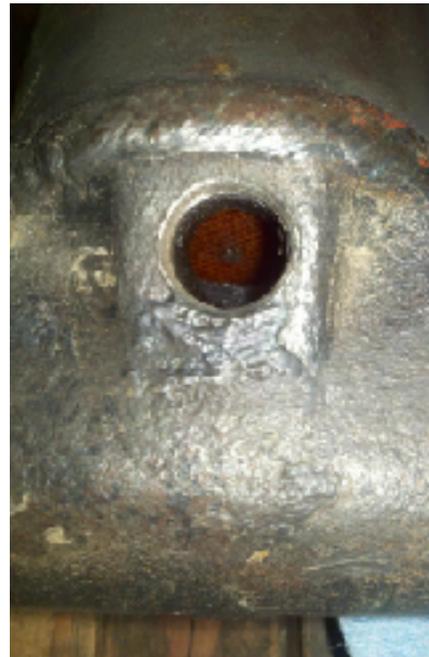
This photo below left, submitted by one of the NAA participants, shows both fiber and aluminum oleo components.

The photo below right, also submitted by a NAA participant, shows the method for inspecting an oleo piston through the oil fill hole to determine if the oleo piston is fiber or aluminum. The photo shows a fiber piston seen through the oil fill hole.

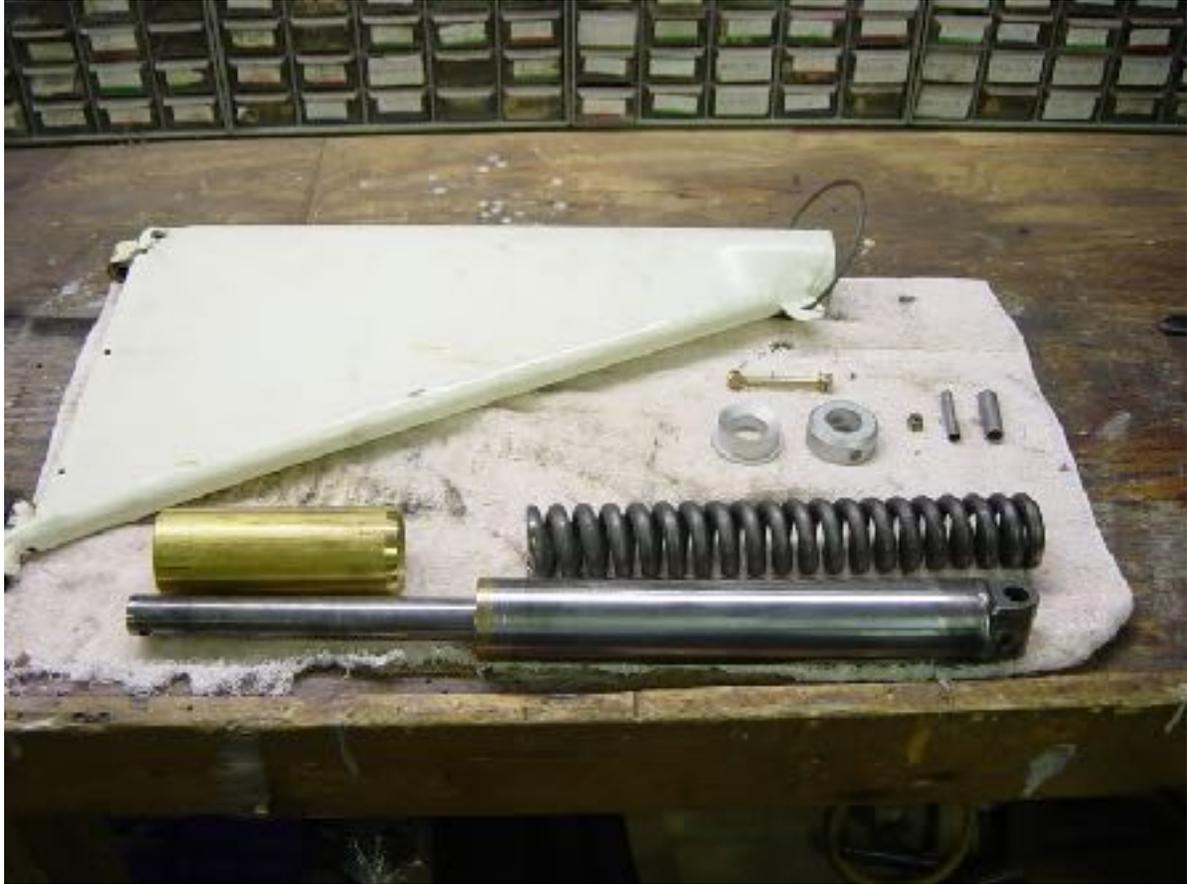
This photo, submitted by Nathan Hammond, shows many of the components that go into a completely assembled oleo assembly.

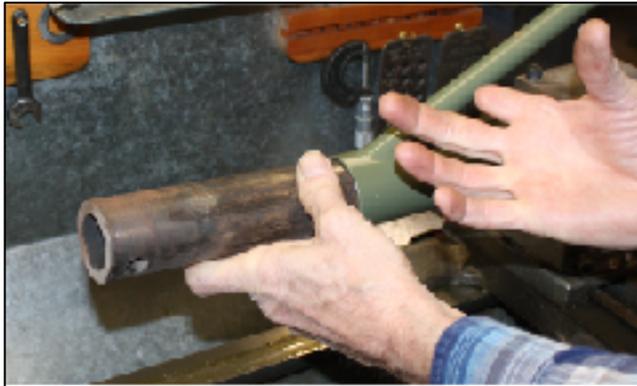
The first tool shown is a simple mandrel that has a tight fit into the end of the oleo frame with the brass bushing removed. This mandrel, which has a loose press fit, is inserted into the

frame whenever the small round brace tube is welded or rewelded to the main oleo tube. This helps prevent the welding process from distorting the oleo tube. Once the weld repair has been completed, Bill has a fixture on his hand arbor press for extracting the mandrel from the oleo case frame. The upper end of the oleo case is

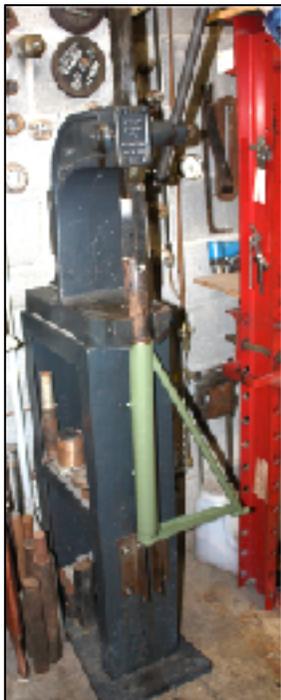
attached to the base of the arbor press, and a couple arms connect the bottom end of the press ram to the end of the mandrel. The arbor press ram is then lifted up to extract the mandrel.

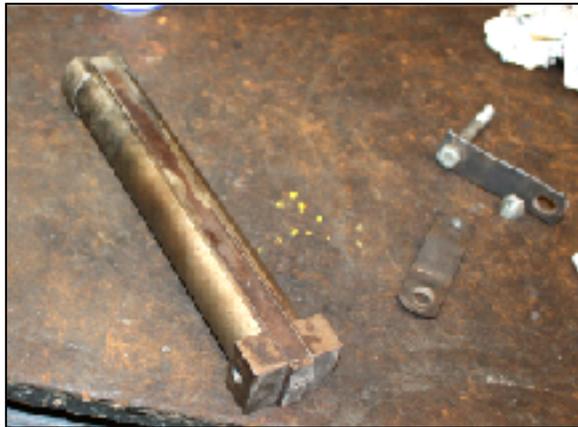
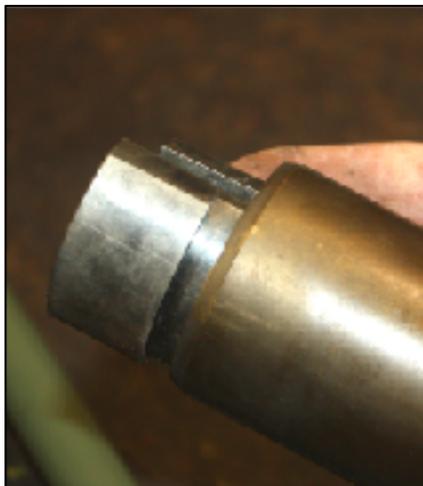
The fixture was fabricated by turning the main body to the approximate diameter of the brass sleeve in the oleo case. A step shoulder was machined in the end of the fixture to hook over the end of the installed bushing in the oleo case.

The two outer pieces of the fixture are inserted first into an oleo case with the hooks beyond the end of the bushing. The center section is then inserted, pressing the two outer sections against the bushing. The clamp bolt is then inserted into the end of the fixture. The

two side pieces of the fixture were bent slightly during fabrication so that when the clamp bolt is inserted into the end of the fixture, the hooked shoulder end of the fixture will clamp tightly against the end of the bushing that is being extracted.

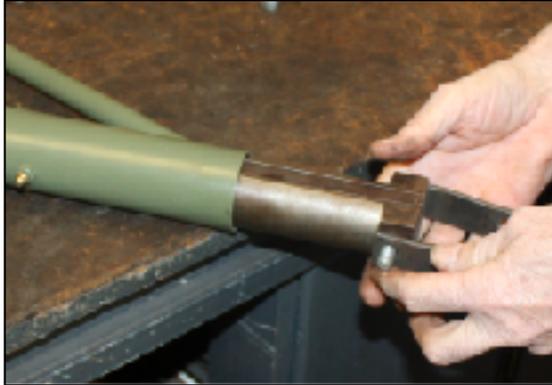
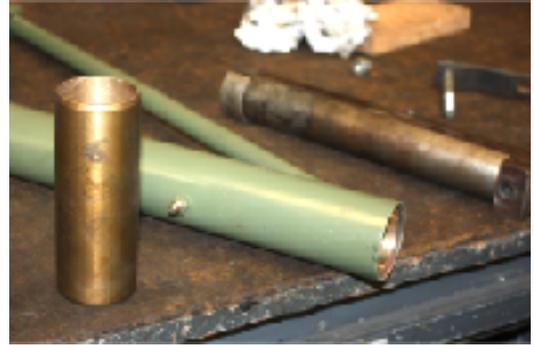
The following photo on the left shows the extraction fixture installed in an oleo case frame. The photo on the right shows a new bushing along side a new oleo case frame. Once the extraction tool is inserted, the oleo case frame mounted in the manual arbor press and the brass bushing is pulled out by lifting up on the arbor press ram.

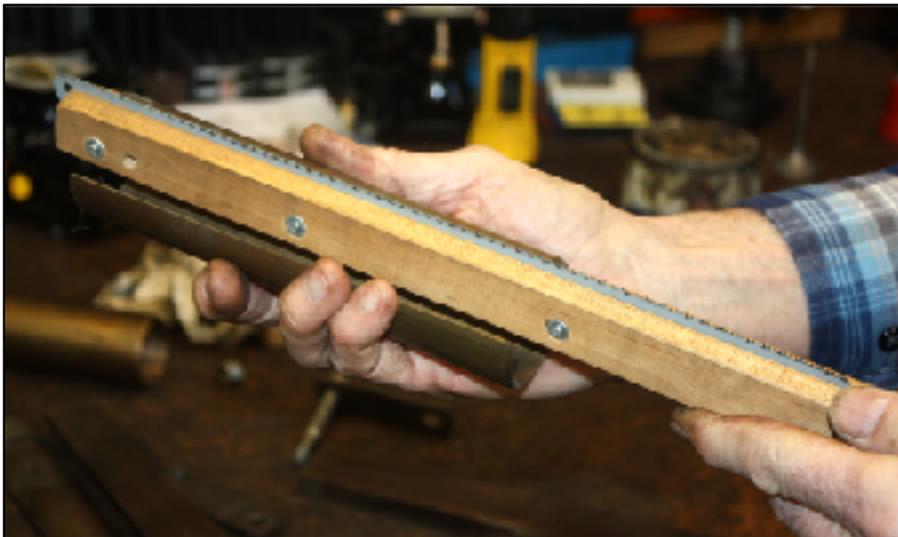
There are other methods for removing the oleo case frame bushings if you don't have a custom built extraction tool. The next photo shows a homemade tool consisting of a piece of

wood, a few bolts, and a hacksaw blade. A slot is cut in the wood for clamping the hacksaw blade. The fine toothed blade is mounted so

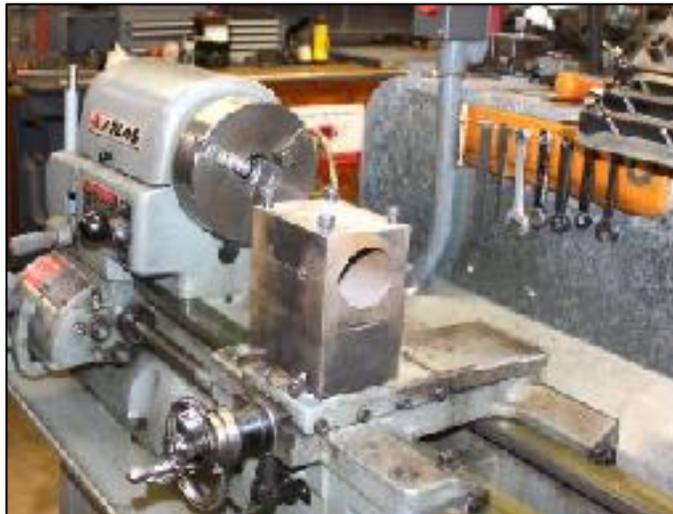
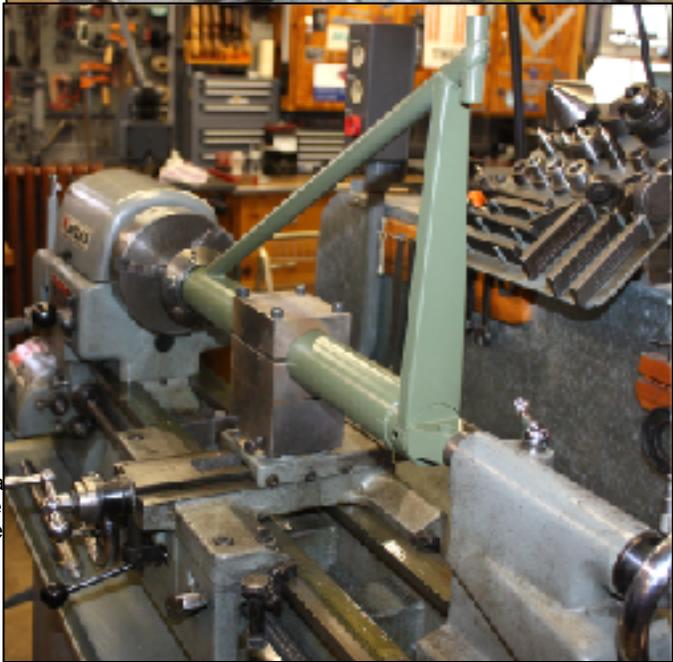
The process used by Bill involved designing and making a fixture to attach to his lathe tool

post to hold the landing gear strut tube parallel to and in line with the center of the lathe chuck. The fixture was machined from a solid block of steel. After boring the fixture to the outside diameter of the strut tube, the fixture was split so that the tube could be clamped horizontally on the centerline axis of the lathe. The oleo case is clamped into the fixture on the lathe and carefully centered on the centerline axis of the lathe.

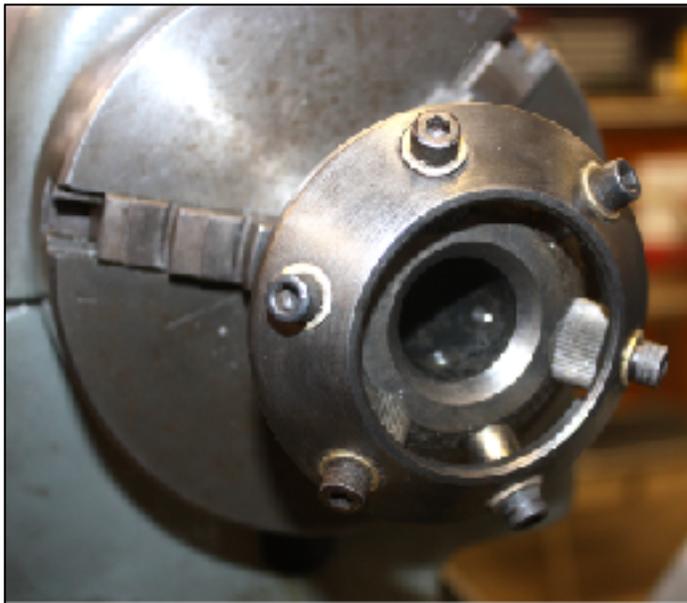
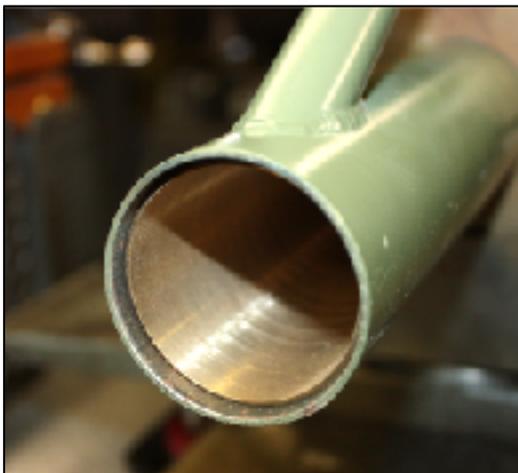
Prior to actually boring the bushing, the new lower end of the strut tube should again be swaged over the end of the new bushing. To do this, Bill designed a knurling fixture with

angled rollers to mount in the lathe chuck. Then, with the lathe running the lathe carriage would be moved to advance the tube end to the knurling (swaging) fixture. The lathe tail post is used to apply additional pressure to force the strut into the knurling tool fixture as shown in the next photo. You may notice that the end of the oleo case frame shown in these photos is not knurled or swaged as shown on the factory photos.

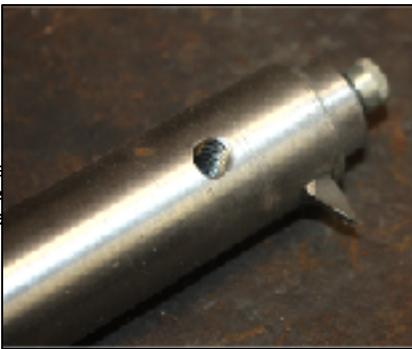
The oleo case shown in the photos is one provided by Wag Aero and they do not swage the ends of their oleo cases. The bushing is held in only by the interference fit.

A boring fixture is then mounted in the lathe chuck that can be adjusted to bore the bushing to a final dimension of 1.749". The bushing is then bored by feeding the tool post toward the boring

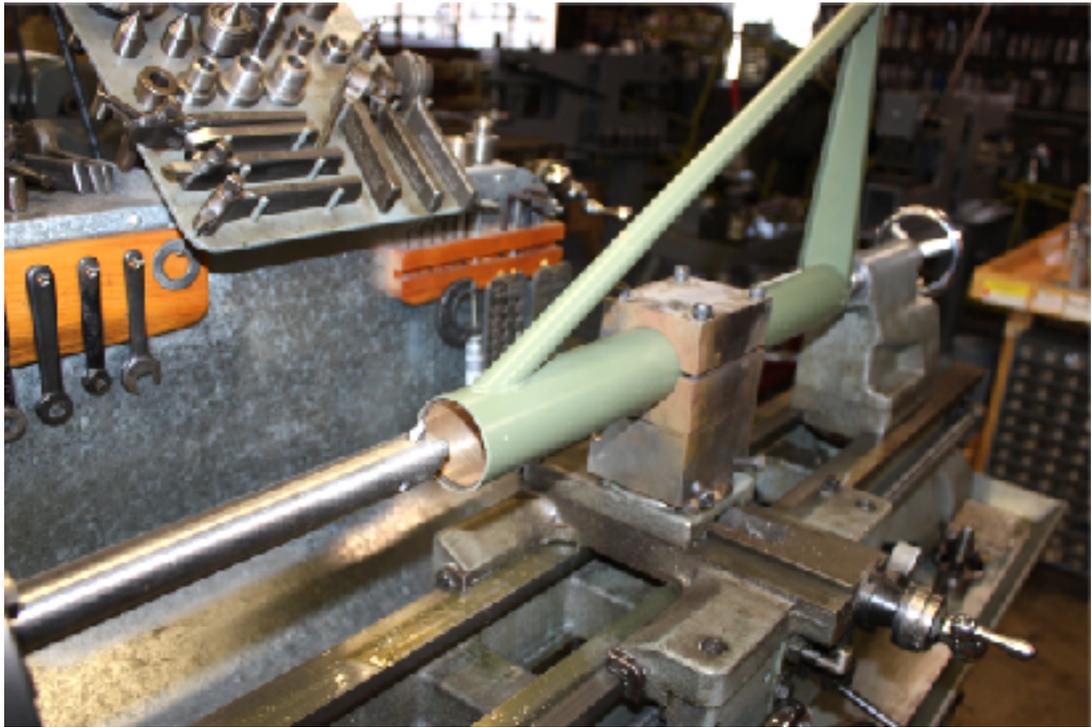
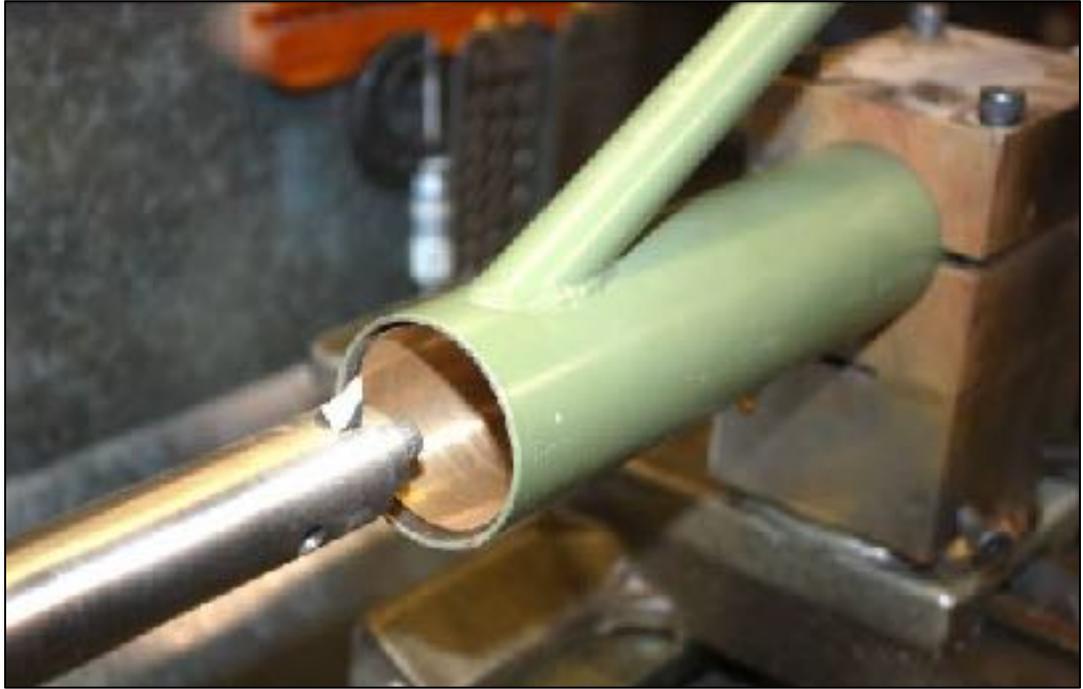
bar with the attached landing gear strut tube into the boring fixture. A course cutting tool is used to rough cut the bore. A round nose tool is then used to clean up the cut. Finally, the brass bushing his honed to the desired finished dimension.

Once the new bushing has been swaged into place and bored to the correct diameter (preferred final clearance between lower tube and bushing is .002" to .004"), the oleo can then be reassembled as previously described in this article.
